Daily Diary Report by Bid Item

Contract No.: 04-0120F4

04-0120F4
 04-SF-80-13.2/13.9
 Self-Anchored
 Suspension Bridge

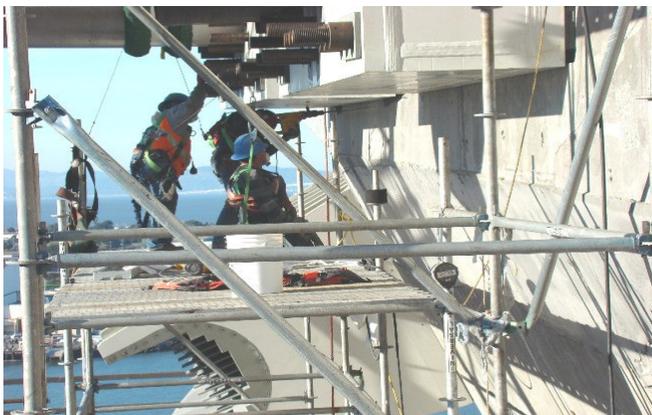
ABF laborers chipping concrete beneath the North W2W Hinge K pipe beam assembly after it was discovered that the assembly needed to be moved back.

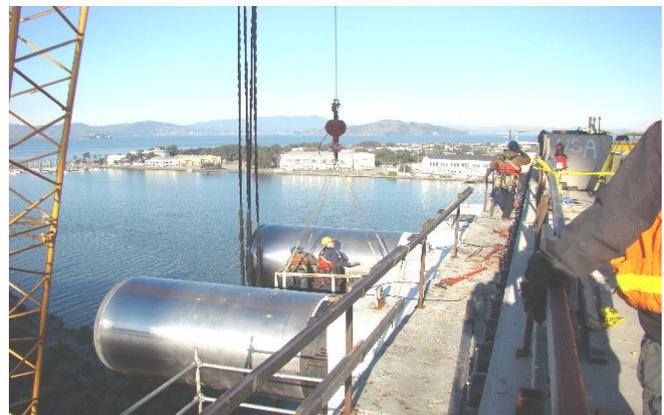
IPMC technician measuring the North W2W Hinge K pipe beam assembly.
