SAS Superstructure

Daily Diary Report by Bid Item

Contract No.: 04-0120F4

04-0120F4
04-SF-80-13.2/13.9
Self-Anchored
Suspension Bridge

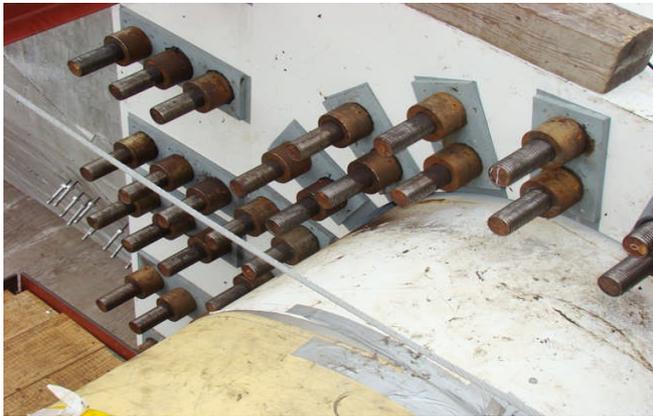
The threads of the Macalloy rods at the North W2E Hinge K pipe beam assembly were cleaned with a grinder for easier installation of the coupler.

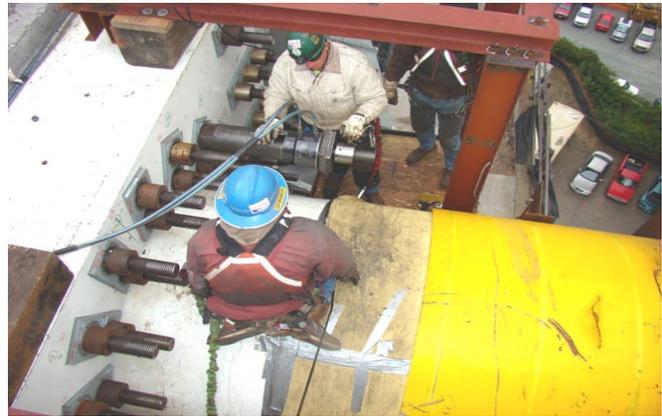
ABF ironworkers in the process of stressing a Macalloy rod at the South W2E Hinge K pipe beam assembly.
