SAS Superstructure

Daily Diary Report by Bid Item

Contract No.: 04-0120F4

04-0120F4
04-SF-80-13.2/13.9
Self-Anchored
Suspension Bridge

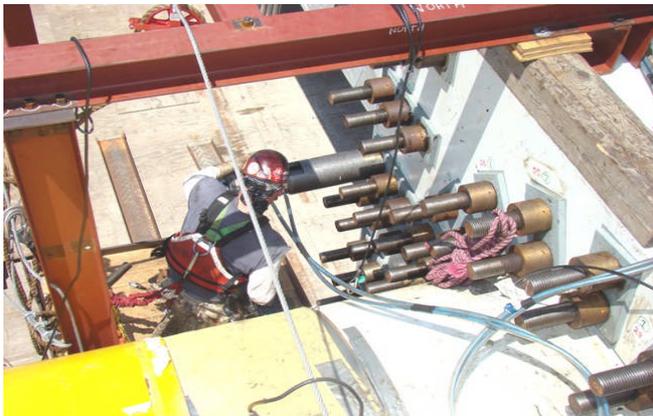
- Attended biweekly SAS Safety Tailgate and staff meetings at 8:00am.
- Assisted Chris Havel with monitoring the Hinge K Macalloy rod stressing operation. No significant problems were encountered with the actual stressing of the Macalloy rods. The only item to note was that the ABF ironworkers began to use the fixed Macalloy jack, see the photo below for more details and comments.
- See Chris Havel, Abbas Iranmanesh, and John Lyons diaries for more details regarding ABF and Macalloy's equipment, labor, and operations for "snugging" (25% of Pjack) the North W2E Hinge K Macalloy rods.
- Attended OBG weekly staff meeting at 3:30pm.

ABF ironworkers using the Macalloy jack that was fixed after hydraulic failure on the left Macalloy rod for row number 10 in the stressing sequence.

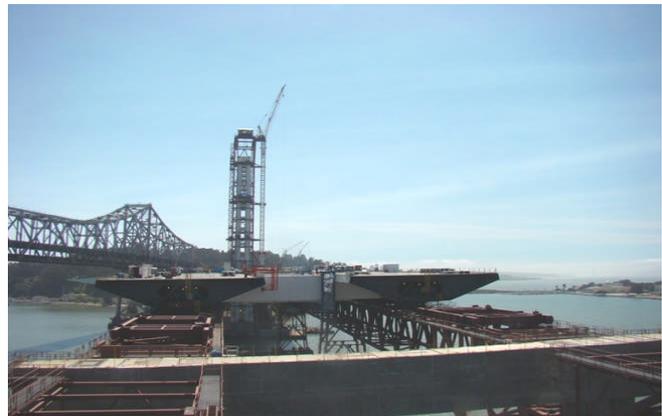
Lifting the tower saddle seen from the eastbound Skyway structure.
