**SAS Superstructure**

**Daily Diary Report by Bid Item**

Contract No.: 04-0120F4

04-0120F4  
04-SF-80-13.2/13.9  
Self-Anchored  
Suspension Bridge

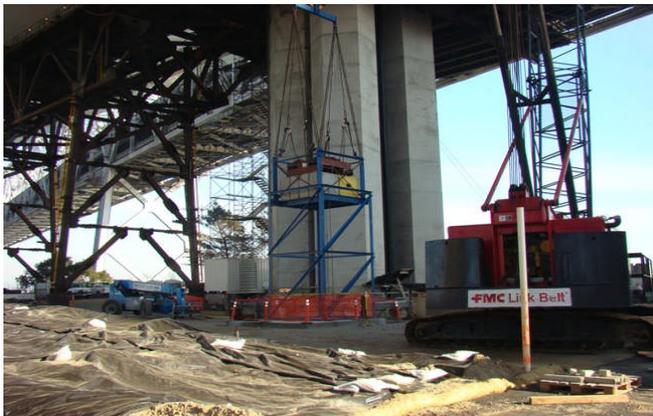
Primary hauling system counterweight in position to apply tension to the hauling cable.

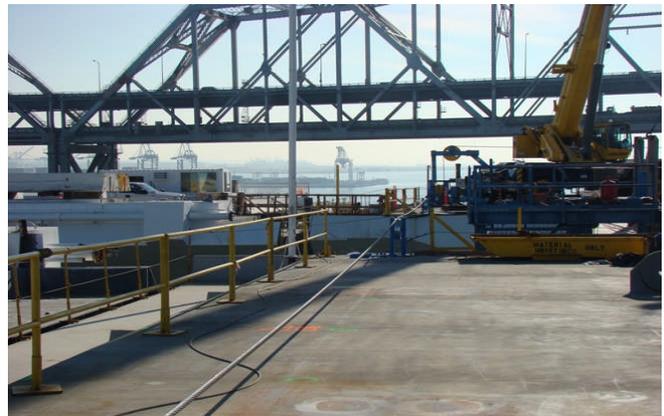
Primary hauling cable not under load between the deflection sheave frame on OBG lift 14E and 14W.

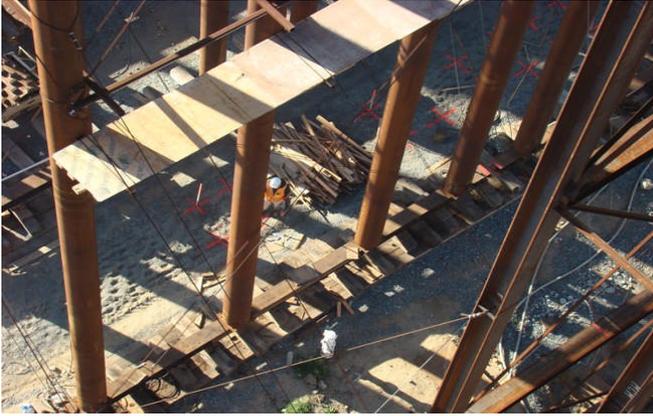
Layout for the W-Line bridge micropiles to be used for the pulldown after post-tensioning to counter the effects of creep in the concrete.

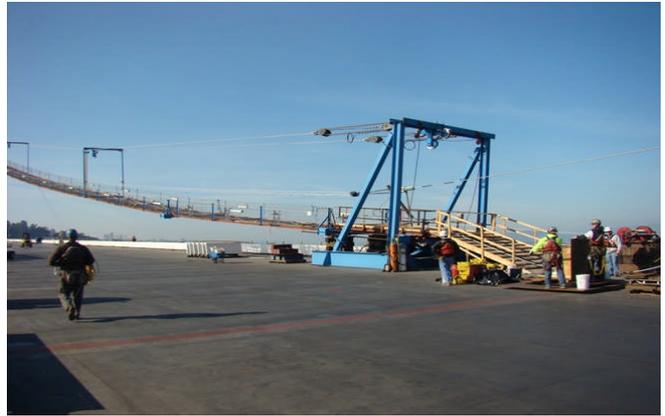
ABF ironworkers positioning the primary hauling cable in preparation of splicing the cable to make one continuous piece.
