SAS Superstructure

Daily Diary Report by Bid Item

Diary #: 514 Const Calendar Day: 902 Date: 27-Feb-2012 Monday
Inspector Name: Bruce, Matt Title: Transportation Engineer
Inspection Type: Intermittent
Shift Hours: 04:00 am 03:30 pm Break: 00:30 Over Time: 03:00
Federal ID:
Location:
Reviewer: Schmitt, Alex Approved Date: Status: Submit

04-0120F4
04-SF-80-13.2/13.9
Self-Anchored
Suspension Bridge

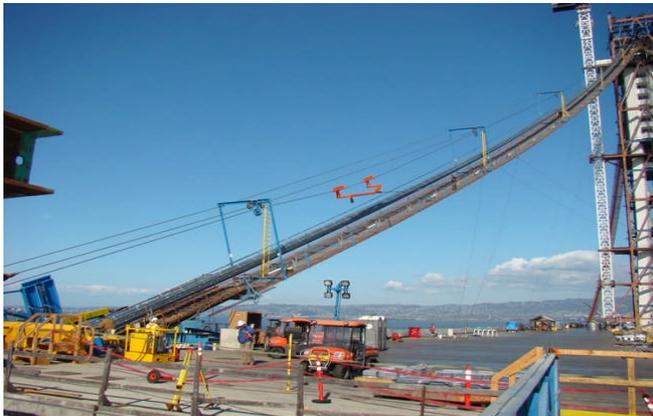
Hauling cable strand number 66 down the north sidespan prior to transferring to the secondary hauling system around the W2 cap beam.

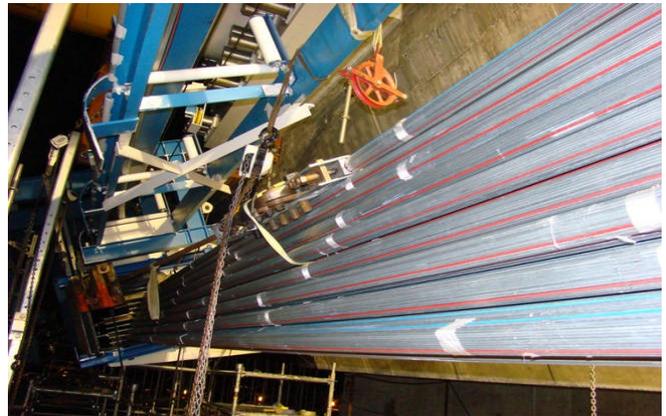
The cable strand adjuster at the W2W west deviation saddle was connected to cable strand number 63 at the north west loop impeding a final measurement.

Comments: Cable strand number 62 was considered to be free-hanging at the time of measurement on the north west-loop. However cable strand number 63 was connected to the strand adjuster. Daryoush took the measurement at this location. I recorded the data while the measurement was being taken. The () denotes the fixed timber block (by ABF) to cable strand number 1 dimension in millimeters.

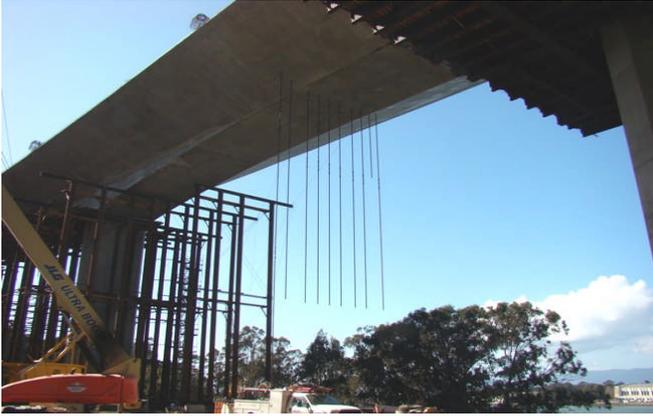
The progress of ABF placing tie rods for the Hinge K tie down system from the top of the YBITS W-Line bridge.

- Prepared for surveying the Hinge K tie-down micropiles and set up equipment in the field. However when I got onsite it was discovered that ABF began placing and connecting the tie rods to the micropiles, essentially preventing me from surveying. This issue was due to the fact that I am dedicated to the cable work while still trying to fit other items of work into my schedule. Also the responsible Caltrans engineers were caught by surprise that this operation/activity was being done at this time.

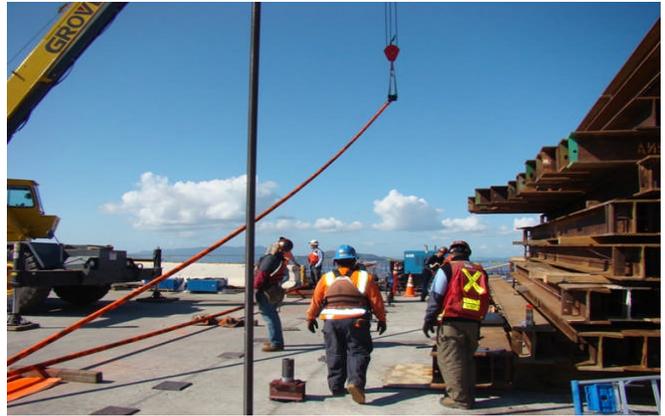
ABF ironworkers and laborers in the process of placing tie rods for the Hinge K tie down system on the YBITS W-Line bridge.
