SAS Superstructure

Daily Diary Report by Bid Item

Diary #: 524 Const Calendar Day: 912 Date: 08-Mar-2012 Thursday

04-0120F4
04-SF-80-13.2/13.9
Self-Anchored
Suspension Bridge

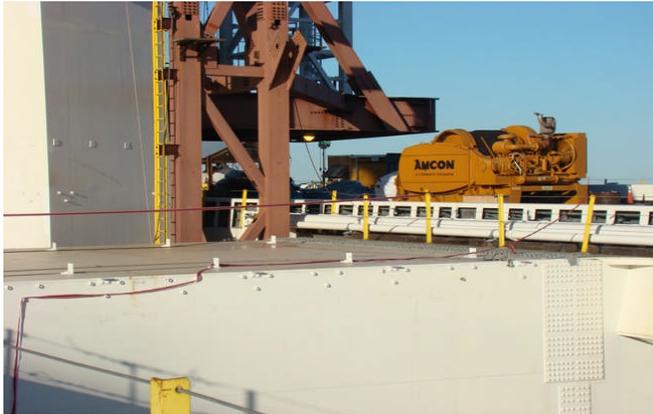
- At or around 7:48am while myself and Damon were walking back to the Skyway to drive back to the Pier 7 office for the safety meeting we heard a loud noise on the W-Line OBG near the tower. ABF had dropped cable strand number 88. I was the first to announce the incident over the SAS talk group on the radio as myself and Damon were close to the accident, see the photo below for more details. We waited until Bob and Roman came to the scene to address the issue with ABF. To my knowledge nobody was hurt in the incident. See Roman and Bob's diaries for more details.

Photo from my location when ABF dropped cable strand number 88 on the W-Line OBG at 7:48am.

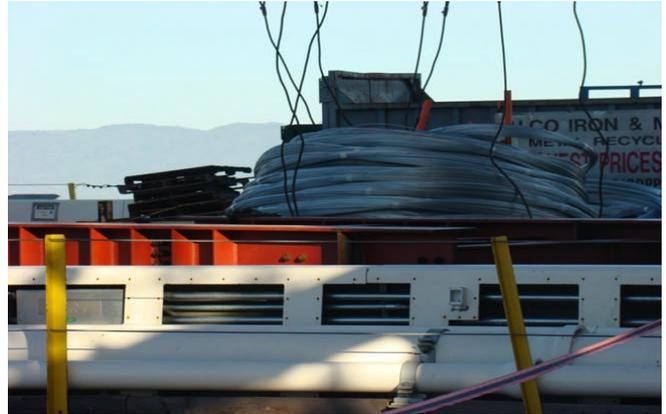
Cable strand number 88 after it was dropped on the W-Line OBG looking north from the E-Line OBG near the tower.

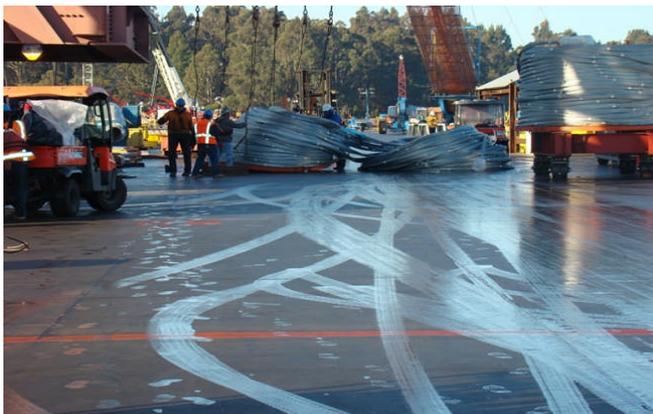
Cable strand number 88 after it was dropped on the W-Line OBG

looking west from the W-Line OBG near the tower.

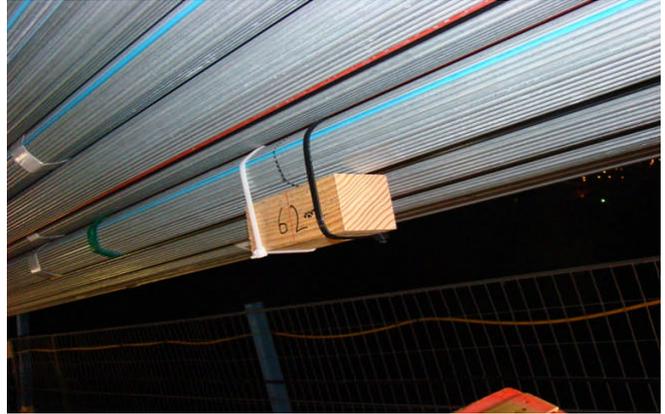
Comments: All cable strands were considered to be free-hanging at the time of measurement on the south sidespan. I took all of the measurements while Daryoush and Damon assisted me with setting up the targets, being level, normal to cable, etc. ABF laborers fixed a timber block to cable strand number 1 just prior to the ABF surveyors and Caltrans engineers taking measurements at this location. Plastic straps were used to fix the timber block to the strand. The timber block was used on cable strand number 1 to obtain all of the measurements where the dimension is in () millimeters. It should be noted that plastic straps made it difficult to obtain proper bearing on the timber block with the Maletic gauge (#1) flat plate.

ABF laborers also fixed a timber block to cable strand number 1 at this location. It was determined that the timber block placed by ABF laborers was too difficult and not efficient when using the Maletic gauge #1, therefore we used our own timber block given the conditional restraints.

Timber block fixed by ABF laborers on cable strand number 1 on the south sidespan today.
