SAS Superstructure

Daily Diary Report by Bid Item

Diary #: 021 Const Calendar Day: 914 Date: 10-Mar-2012 Saturday

04-0120F4
04-SF-80-13.2/13.9
Self-Anchored
Suspension Bridge

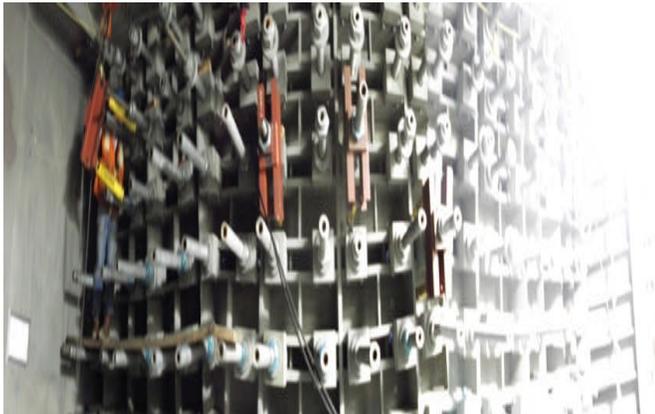
The AnchorageJackingArea

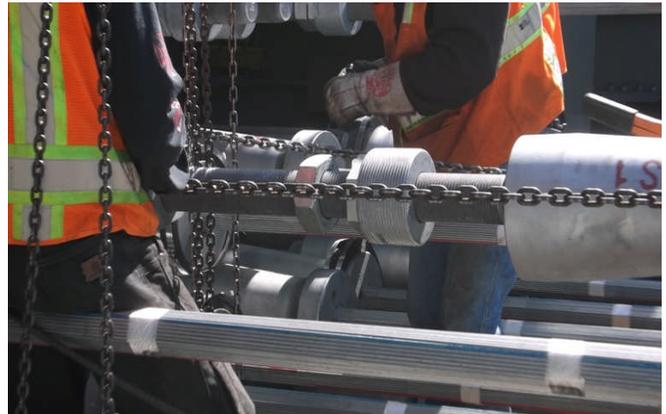
CouplingStrand90North

- Begin Installation of Strand #90 North at about 11:45;
- Connect socket to the Anchor Rod for Strand #90 North at about 11:45 and measured the Engagement and Sick-out lengths. The former was about 105mm (>100mm) and the latter 8mm, which is <10mm-both GOOD. It should be noted that an extension rod was attached to the anchor rod at this location with a length of 1310mm. This was the strand that was burned a while ago and spare PWS # S01 is taking its place.
