SAS Superstructure

Daily Diary Report by Bid Item

Diary #: 314 Const Calendar Day: 997 Date: 01-Jun-2012 Friday
Inspector Name: Wright, Doug Title: Transportation Engineer
Inspection Type: Continuous
Shift Hours: 07:00 AM 06:40 PM Break: 00:30 Over Time: 03:00
Federal ID:
Location:
Reviewer: Schmitt, Alex Approved Date: Status: Submit

04-0120F4
04-SF-80-13.2/13.9
Self-Anchored
Suspension Bridge

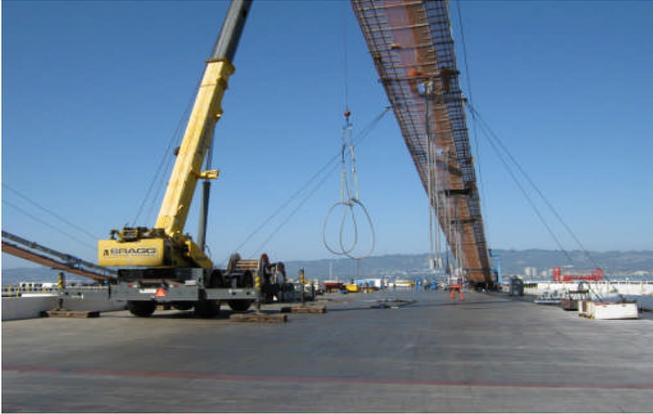
- Note: While they were installing the suspender at PP88S, they rigged it in a way that is not in accordance with the approved submittal. This suspender was installed with a crane. The approved submittal details the rigging to be used when installing with a crane (suspender supported at the mid-point with the sockets free hanging). At PP88S, they rigged between the sockets & the zinc buttons to loop the suspender back on itself, & then they laid the suspender onto the catwalk to remove the extra rigging before guiding the sockets through the holes in the catwalk. See attached photo. I spoke with ABF Engineer Adam Reeve & Superintendent Dave Meche, & told them that this is not acceptable.

Suspender installation at PP88S not in accordance with the approved submittal

- At 17:05, Richard's crew & Obra's crew wrapped up the tools to end their shift.
- At 17:10, I left the bridge.
- From 17:20 until 18:00, I spoke with Roman Granados & Warren Collins regarding the suspender installation at PP88S that was not in accordance with the approved submittal. I gave photographs to them showing how the suspender was being installed, & they agreed that it was not acceptable. Warren was planning to send an email to ABF Engineer Kevin Smith to let ABF know that we do not consider this method of installation acceptable.
