SAS Superstructure

Daily Diary Report by Bid Item

Diary #: 093 Const Calendar Day: 18 Date: 22-Jun-2012 Friday
Inspector Name: Soheilifard, Saman Title: Transportation Engineer
Inspection Type: Continuous
Shift Hours: 07:15 am 06:15 pm Break: 00:00 Over Time: 03:00
Federal ID:
Location:
Reviewer: Schmitt, Alex Approved Date: Status: Submit

04-0120F4
04-SF-80-13.2/13.9
Self-Anchored
Suspension Bridge

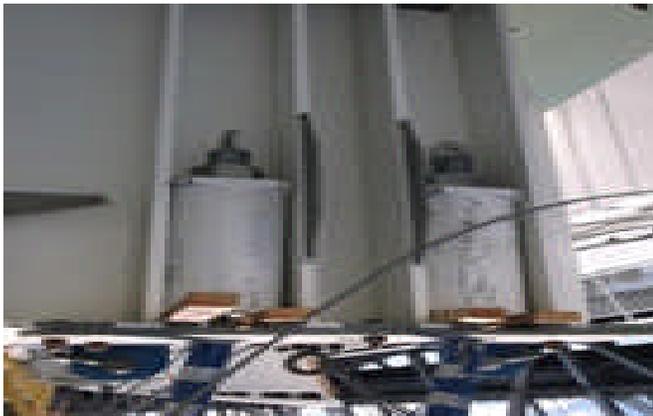
EPP34-DamageToBracket& Sockets (1)

While inspecting the paint on the sockets, I noticed that ABF has placed the two Uphill sockets at PP 34 in the bracket. As a result, the paint on the socket and the bracket were further damaged. Moreover, at PP 62, the sockets had been taken off the donnage and laid on the ground as shown in the photo. There are other locations where the sockets are resting on the deck with all the weight of the socket bearing down on one corner of the base of the socket.
