SAS Superstructure

Daily Diary Report by Bid Item

Diary #: 696 Const Calendar Day: 136 Date: 18-Oct-2012 Thursday

04-0120F4
04-SF-80-13.2/13.9
Self-Anchored
Suspension Bridge

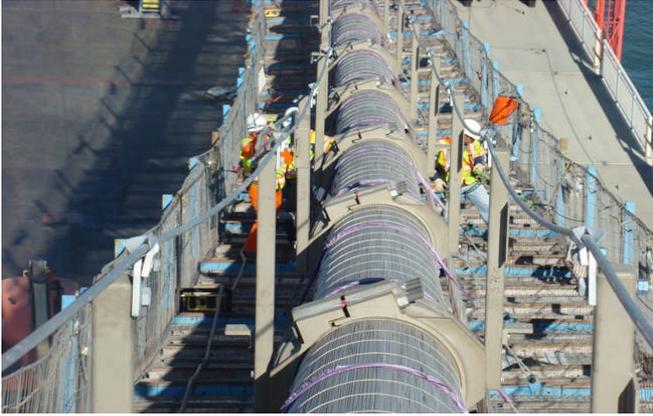
Caltrans Extensometer crew taking measurements on South Mainspan cable band bolts.

-Used the Caltrans CT-1 Extensometer to measure bolt elongations for the following cable bands which are being done during the day and night to investigate if the thermal expansion of the steel effects the bolt elongation/force:

The measurements were taken by myself, John Lyons, Alex Schmitt and Victor Pereyra. John took the majority of the readings on the digital dial and recorded the number. Alex, Victor, and myself positioned/handled the Extensometer on the cable band bolts. Since thermal effects are being considered I was taking ambient and steel temperatures. The anemometer was used for the ambient temperature and the infrared gun was used for the steel temperature. While using the infrared gun the most reliable location where the steel temperature was taken was on the cable band casting. The readings on the main cable were too unstable and were not considered to be valid.

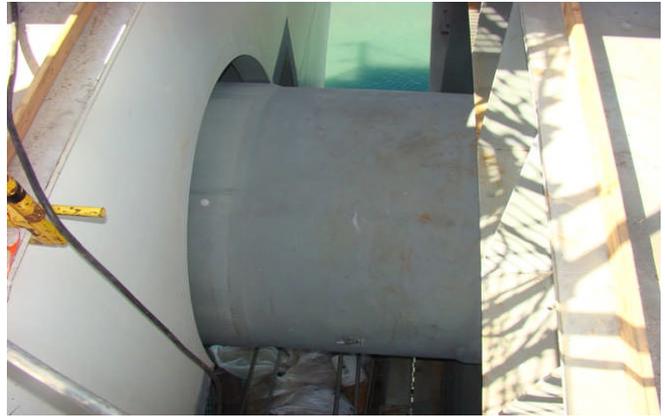
The W-Line North Hinge A pipe beam was pulled through the SAS sleeves today.

- Processed and analyzed the Hinge A pipe beam surveying data done Tuesday night and early Wednesday morning. Reviewed and summarized the survey with Bob Brignano, he sent out the email to inform pertinent TY-Lin and Caltrans personnel associated with this operation the results.

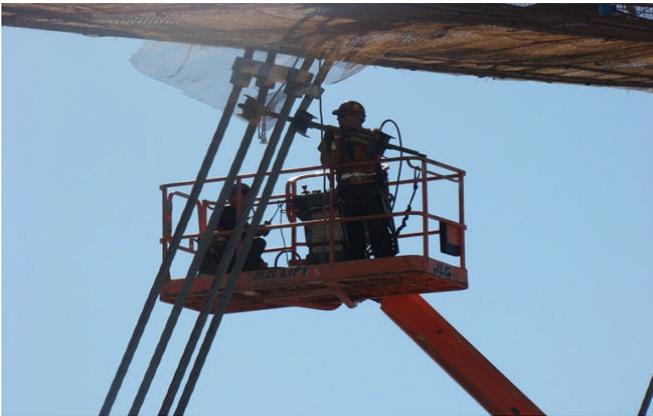
Pulling the suspender ropes together with jacks to enable installation of the suspender collars.

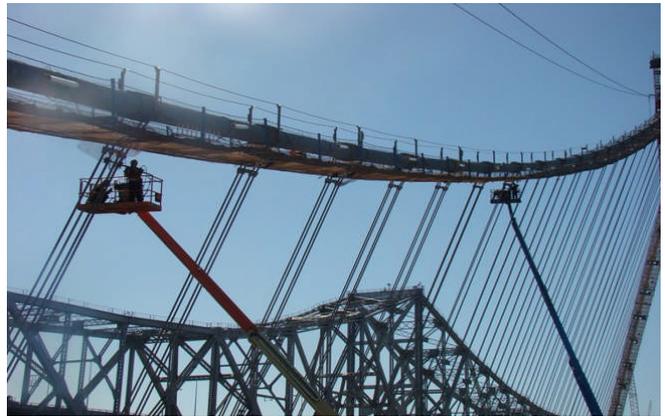
ABF ironworkers installing suspender rope collars on the South Mainspan.
