**Daily Diary Report by Bid Item**

Contract No.: 04-0120F4

04-0120F4  
 04-SF-80-13.2/13.9  
 Self-Anchored  
 Suspension Bridge

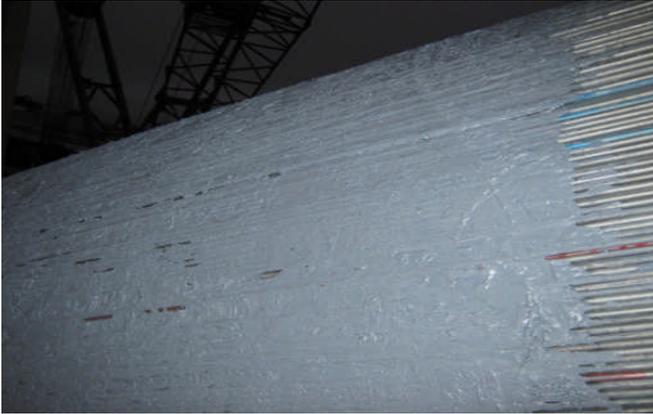
- I arrived at the pier 7 office at 06:40, & was on the bridge at 06:50.
- From 06:50 until 07:00, prior to the iron-workers getting to the work site, I inspected the condition of the zinc paste that was applied yesterday, & was covered overnight. The zinc paste was in good condition (no moisture, etc). There were a couple of areas where the plastic sheets pulled away some of the zinc paste (see attached photo). Additional zinc paste was applied in these areas prior to starting the wrapping work.

Condition of zinc paste when plastic covering removed (paste applied to the minor areas where paste pulled away)

- From 07:00 until 07:30, the zinc paste was added to the Cable in areas where the plastic sheets pulled the paste off the wires.
- At 07:30, the wrapping machine was moved down close to the cable band (CB) at PP 10S to get ready to start wrapping.

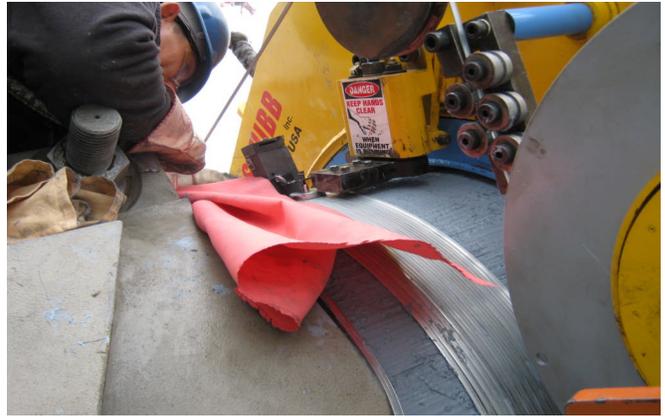
- From 09:20 until 10:00, the Cadwelds were placed on the S-wires near the top of the Cable to secure the S-wires in place. See attached photo.
- From 10:10 until 10:30, the 125mm section of the wrapped S-wire was knocked down to lap below the CB caulking groove. The S-wire slid fairly easily with minimal knocking.

Cadwelds being placed to secure S-wire in place

- Note: after the wrapping wire was removed, I inspected the Cable to check for various issues. Near the top of the Cable where they had placed the Cadwelds, there was no evidence of any burn-through or scorching of the zinc paste. Also, the zinc paste appeared to be in good overall condition.
