SAS Superstructure

Daily Diary Report by Bid Item

Diary #: 770 Const Calendar Day: 235 Date: 25-Jan-2013 Friday
Inspector Name: Bruce, Matt Title: Transportation Engineer
Inspection Type: Intermittent
Shift Hours: 09:00 am 05:30 pm Break: 00:30 Over Time:
Federal ID:
Location:
Reviewer: Schmitt, Alex Approved Date: Status: Submit

04-0120F4
04-SF-80-13.2/13.9
Self-Anchored
Suspension Bridge

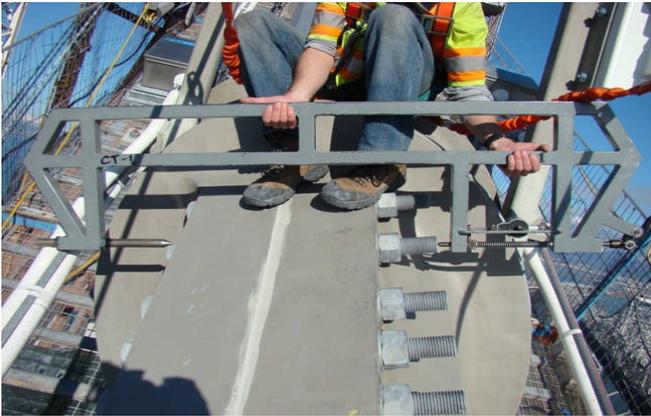
Extensometer 1 typical conflict with the messenger cable on the top row of bolts of the cable band at PP36S.

- Checked and investigated the amount to cut the Extensometer frame on cable bands 36S and 48S with the assistance of John Lyons. As mentioned before the messenger cable, stanchion posts, and electrical pullboxes obstruct the Extensometer from measuring the top row of cable band bolts. Emailed photos to Warren Collins to start negotiations with ABF to perform modifications of the Extensometer, see photos below for more details.

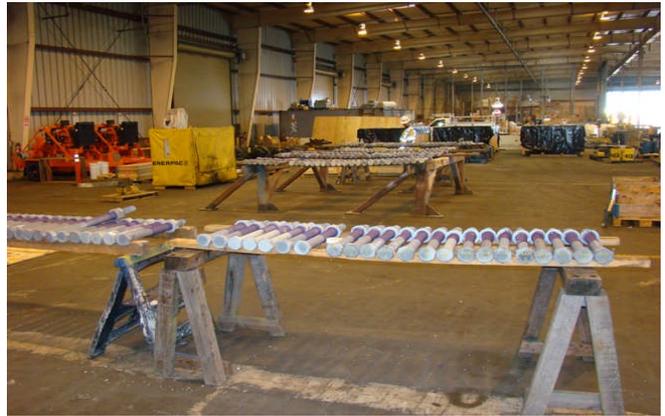
Replacement bolts for cable bands 40N, 40S, 44N, and 44S in the Pier 7 warehouse where the unstressed lengths were measured today.

- Used the Caltrans CT-1 Extensometer to measure the unstressed replacement bolts for the following cable bands:

40N, 40S, 44N, 44S

The measurements were taken by myself, John Lyons, and Bob Brignano. John and Bob took the readings on the digital dial for the first round of measurements on all of the bolts and recorded the number. Since there was a discrepancy between Caltrans and ABF numbers on cable band 40N, we re-measured the bolts again with Bob taking the readings. The bolts were placed in the Pier 7 warehouse on racks, therefore thermal effects were considered inconsequential.

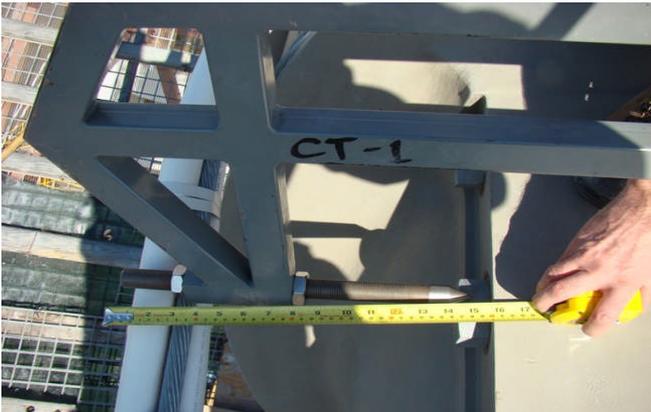
Distance seen to possibly cut and modify the Extensometer to enable measurement of these bolts.

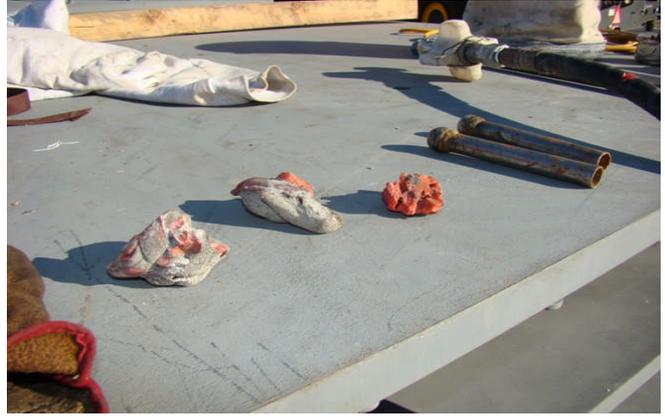
Concrete dust and epoxy debris jetted out of transverse tendon CBT-9 duct today.

- Continued water blasting debris and cleaning the duct for transverse tendon CBT-9 in the W2 cap beam. Today there was progress in breaking up some of the unwanted residual epoxy and concrete dust in the duct, however it appears that it will be a slow process before strand can be installed inside the duct.
