Daily Diary Report by Bid Item

Diary #: 506 Const Calendar Day: 280 Date: 11-Mar-2013 Monday
 Inspector Name: Wright, Doug Title: Transportation Engineer
 Inspection Type: Continuous
 Shift Hours: 07:00 AM 04:00 PM Break: 00:30 Over Time: 00:00
 Federal ID:
 Location:
 Reviewer: Soheilifard, Saman Approved Date: Status: Submit

04-0120F4
 04-SF-80-13.2/13.9
 Self-Anchored
 Suspension Bridge

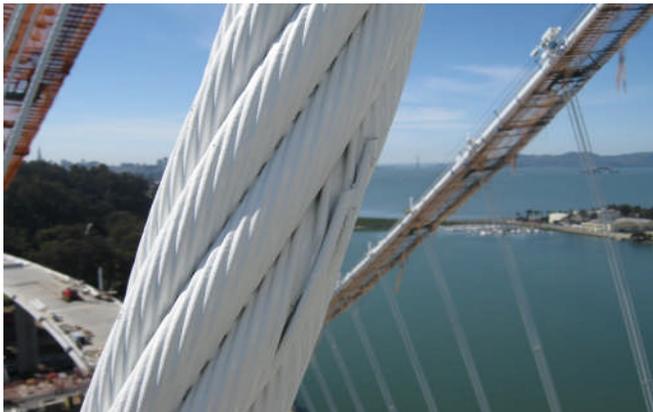
- At PP 36S, 2 broken wires were found. Their location was about 0.6m above the upper separator. See attached photo. The fracture plane was at about a 45 degree angle. The loose tails on both wires were cut free using a dremmel cutting tool, & the wires were saved for further evaluation. After the tail was cut free, the cut end of the wire was coated with one coat of organic zinc primer (wasser MC zinc-100).

Broken wire on suspender rope at PP 36S (East rope)

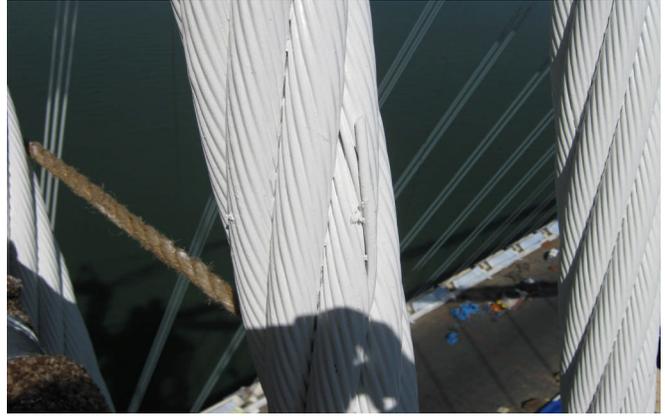
- At PP 46S, one broken wire was found. Its location was about 3.4m above the upper separator, & about 14.2m below the zinc button. See attached photo. The fracture plane was at about a 45 degree angle.

Broken wire on suspender rope at PP 46S (South rope)

The loose tail on the wire was cut free using a dremmel cutting tool, & the wire was saved for further evaluation. After the tails were cut free, the cut end of the wires were coated with one coat of organic zinc primer (wasser MC zinc-100).

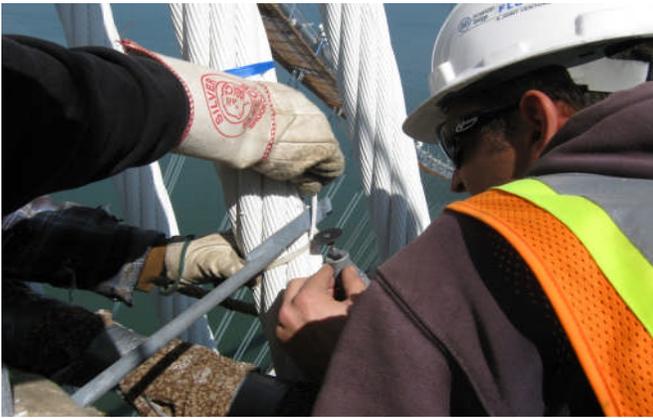
Cutting tail of broken wire with dremmel for future evaluation of the broken wire
