SAS Superstructure

Daily Diary Report by Bid Item

Diary #: 819 Const Calendar Day: 306 Date: 06-Apr-2013 Saturday

04-0120F4
04-SF-80-13.2/13.9
Self-Anchored
Suspension Bridge

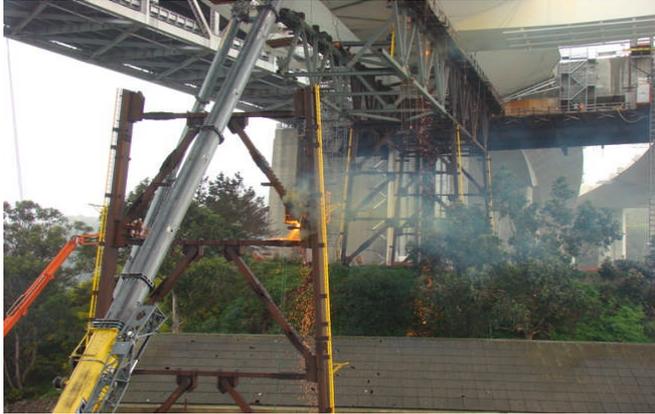
Temporary truss removal along the E-line seen from the west side of the T1 foundation stairways.

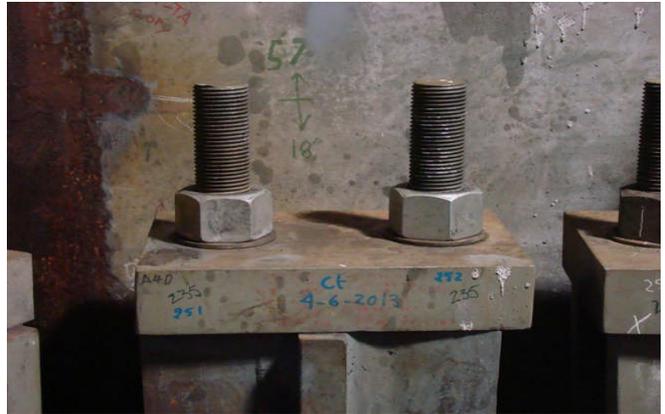
It was known that anchor rods b1(W)05,06,11,&12 were never stressed due to access for electroslag welding. ABF ironworkers cleaned, filed down, sprayed WD40, used a thread chaser and dye to prepare the threads of these four rods. The pressure cycles observed while stressing anchor rods b1(W)05 and 06 for the first time were 5.9ksi, 11.0ksi, and 13.2ksi. Elongations for anchor rod 5 was 235-251 = 16mm, and for rod 6 the change in length was from 235-252 = 17mm. Similarly pressure cycles for anchor rods b1(W)11 and 12 stressed for the first time were 4.7ksi, 8.6ksi, and 13.2ksi. Elongations for anchor rod 11 was 231-242 = 11mm, and for rod 12 the change in length was from 232-246 = 14mm. Overall there was no significant issues when verifying the load in the anchor rods at this location today.

Anchor rods b1(W)05 and 06 stressed for the first time today.
