Contract #: 04-0120F4  
 Cty: SF/ALA Rte: 80 PM: 13.2/13.9  
 File #: 69.15

**SOURCE INSPECTION REPORT**

**Project Name:** SAS Superstructure **OSM Arrival Time:** 800  
**Prime Contractor:** American Bridge/Fluor Enterprises, a JV **OSM Departure Time:** 1530  
**Contractor:** Zhenhua Port Machinery Company, Ltd (ZPMC), Changxing Island **Location:** Shanghai, China

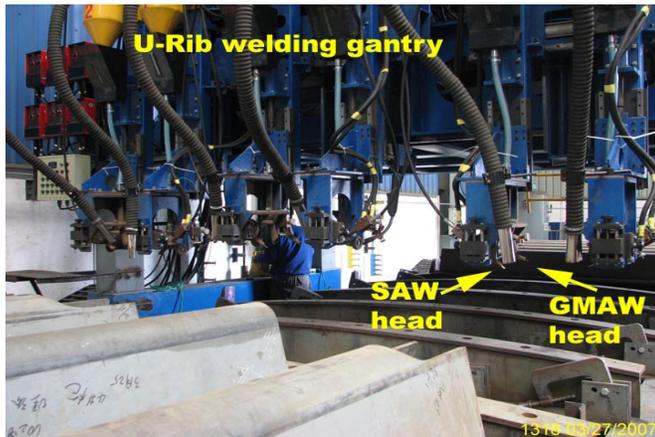
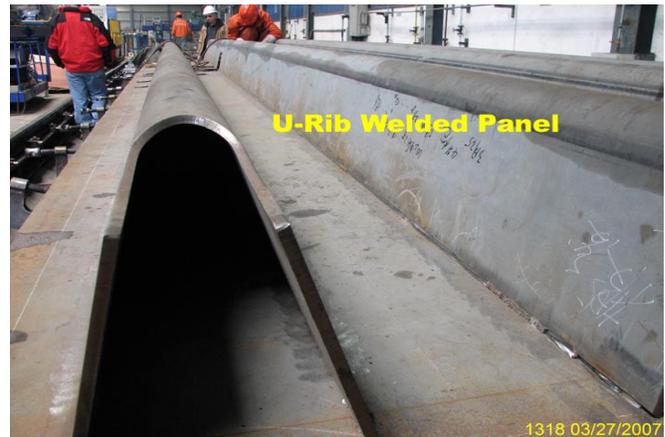
Caltrans Quality Assurance (QA), Welding Engineer Jim Merrill and ABF representative David McQuaid went to the shop location on Changxing Island where ZPMC has their U-rib Welding Gantry. ZPMC is currently conducting internal U-rib welding trials to commission their equipment, fix weld head tracking issues, and begin procedural development. QA observed that the Gas Metal Arc Welding (GMAW) heads are in-place and that 3 practice panels have been welded. It appears the majority of the panels were welded with manual GMAW for the root pass. Only 3 of the ribs on the last panel appear to have had the root pass welded using the dual head, GMAW root with trailing Submerged Arc Welding (SAW) fill. The welds observed exhibit pore profiles and melt-through. Mr. McQuaid estimates another at least another 3 weeks of internal trials before ZPMC begins producing acceptable welds.
