**DEPARTMENT OF TRANSPORTATION**

Contract #: 04-0120F4Cty: SF/ALA Rte: 80 PM: 13.2/13.9File #: 69.15**SOURCE INSPECTION REPORT****Resident Engineer:** Pursell, Gary**Address:** 333 Burma Road**City:** Oakland, CA 94607**Report No:** SIR-000039**Date Inspected:** 14-Apr-2007**Project Name:** SAS Superstructure**OSM Arrival Time:** 800**Prime Contractor:** American Bridge/Fluor Enterprises, a JV**OSM Departure Time:** 1630**Contractor:** Zhenhua Port Machinery Company, Ltd (ZPMC), Changxing Island **Location:** Shanghai, China**Quality Control Contact:** Lu Jian Hua**Quality Control Present:** Yes No**Material transfer:** Yes No N/A**Sampled Items:** Yes No N/A**Stock Transfer:** Yes No N/A**OK to Cut:** Yes No N/A**Rebar Test Witness:** Yes No N/A**Delayed/Cancelled:** Yes No N/A**Other:** NA**Bridge No:** 34-0006**Component:** NA**Bid Item:** 52, 55**Lot No:** NA**Summary of Items Observed:**

# SOURCE INSPECTION REPORT

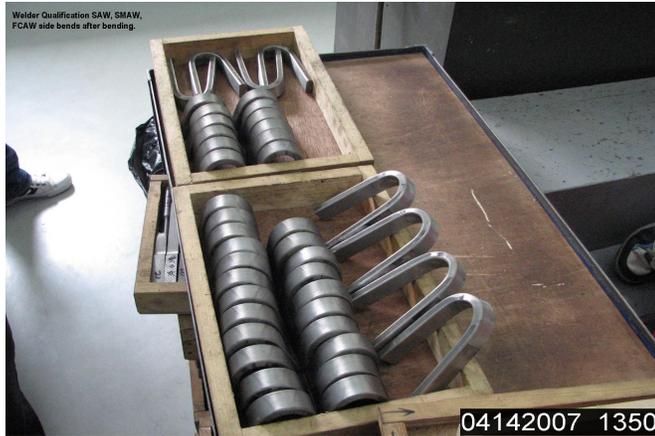
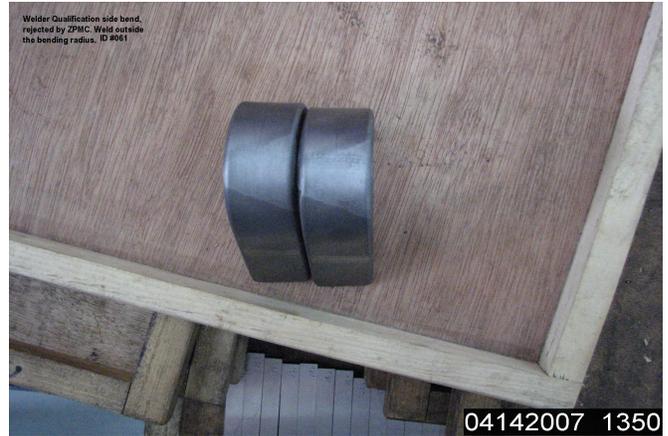
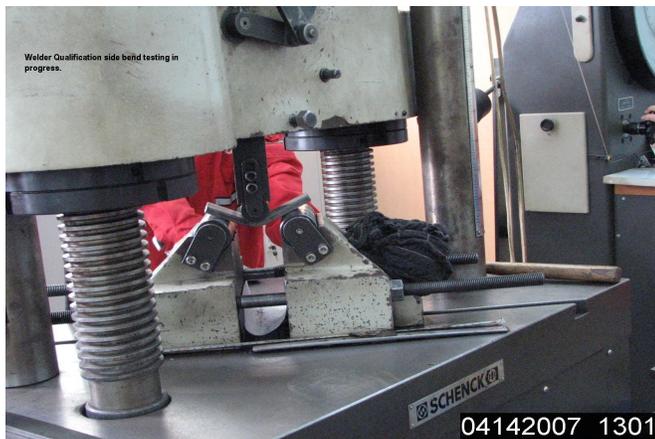
The side bends were visually inspected by ZPMC QA Inspector, Mr. Lu and Moody International Inspector, Mr. Jiang. The side bend specimen identified as #070403061 was rejected due to the weld and heat effect zone being outside the bent portion after bending. All the other side bend specimens were accepted by Mr. Lu and Mr. Jiang. Caltrans QA observed that the test and evaluation appear to comply with contract document requirements.
