Contract #: 04-0120F4Cty: SF/ALA Rte: 80 PM: 13.2/13.9File #: 69.15**SOURCE INSPECTION REPORT****Resident Engineer:** Pursell, Gary**Address:** 333 Burma Road**City:** Oakland, CA 94607**Report No:** SIR-000139**Date Inspected:** 30-Oct-2007**Project Name:** SAS Superstructure**OSM Arrival Time:** 1400**Prime Contractor:** American Bridge/Fluor Enterprises, a JV**OSM Departure Time:** 2300**Contractor:** Zhenhua Port Machinery Company, Ltd (ZPMC), Changxing Island **Location:** Shanghai, China

Other: N/A**Bridge No:** 34-0006**Component:** 77 Meter Mock-Up**Bid Item:** 52 (SF)**Lot No:** N/A**Summary of Items Observed:**

SOURCE INSPECTION REPORT

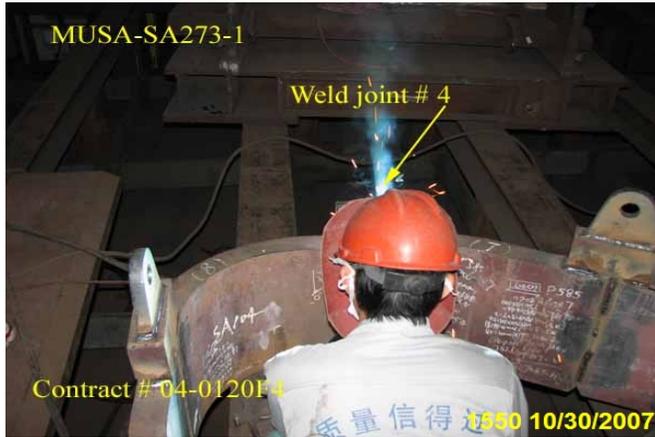
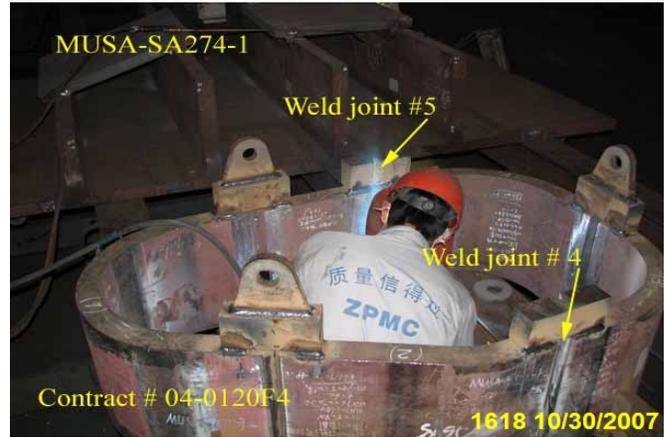
This QA Inspector witnessed the in process welding of 77 Meter Mock-Up MUSA-SA273 inside weld joint # 4 between piece marks identified as p585 and p615 also weld joint # 5 between piece marks p573 and p1082. The ZPMC Certified Welding Inspector (CWI) Zhu Zhonghai informed the QA Inspector the approved welding procedure specification WPS-B-T-223-B-U3-F was being followed to perform the welding.

The ZPMC approved qualified welder Wong Bing ID # 048696 was utilizing Flux Cored Arc Welding (FCAW) process in the vertical (3G) position with the 1.4 mm diameter electrode designated as E71T-1 /AWS A5.20, brand name Supercored. This QA Inspector observed the ZPMC Quality Control (QC) personnel Zhang Giao check the welding machine amperes at 205 and 24 volts using a voltage meter, This QA Inspector Dixon also performed random verification of the weld parameters using a Fluke meter.

This QA Inspector witnessed the in process welding of 77 Meter Mock-Up MUSA-SA274 inside weld joint # 4 between piece marks identified as p585 and p615 also weld joint # 5 between piece marks p573 and p1082. The ZPMC Certified Welding Inspector (CWI) Zhu Zhonghai informed the QA Inspector the approved welding procedure specification WPS-B-T-223-B-U3-F was being followed to perform the welding.

and determined that the welding and work in progress on the items listed above appeared to comply with WPS and the contract documents. See photographs below to provide additional detail.
