Contract #: 04-0120F4Cty: SF/ALA Rte: 80 PM: 13.2/13.9File #: 69.15**SOURCE INSPECTION REPORT****Resident Engineer:** Pursell, Gary**Address:** 333 Burma Road**City:** Oakland, CA 94607**Report No:** SIR-000549**Date Inspected:** 22-Apr-2009**Project Name:** SAS Superstructure**OSM Arrival Time:** 0**Prime Contractor:** American Bridge/Fluor Enterprises, a JV**OSM Departure Time:** 12**Contractor:** Zhenhua Port Machinery Company, Ltd (ZPMC), Changxing Island**Location:** Changxing Dao, Shanghai

Other: Surface Preparation and Coatings Application**Bridge No:** 34-0006**Component:** OBG 2AE, 2BE**Bid Item:** 79, 80, 81**Lot No:** B226**Summary of Items Observed:**

SOURCE INSPECTION REPORT

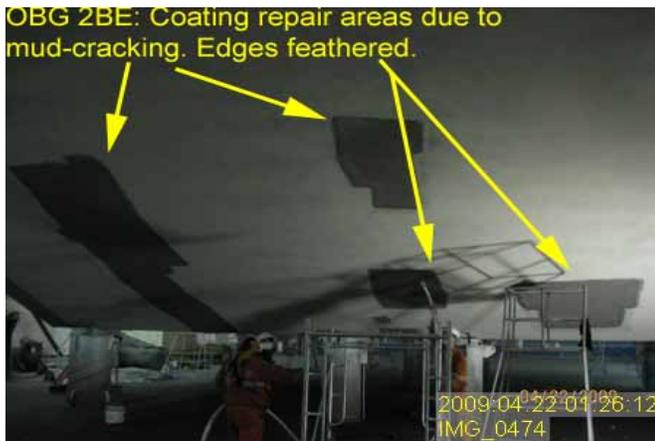
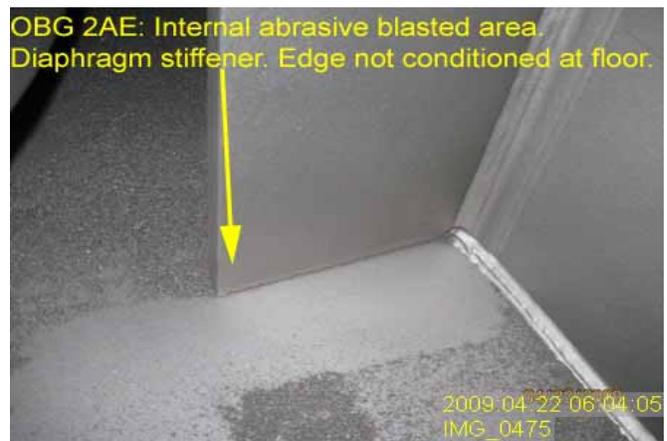
Caltrans QA Coatings Inspectors received a Notice of Inspection for to attend a joint inspection with ABF and ZPMC QC for abrasive blast surface preparation on the exterior of OBG 2 BE. Areas where mud-cracking in the primer coat was identified was removed by abrasive blasting. The areas were inspected and approved for primer application. The edges were feathered in by wire wheel grinding. The feathered area was taped off prior to applying the Interzinc 22 to prevent the primer from overlapping the cured coating. ZPMC's intent was after the primer has cured the tape will be removed and Interzinc 52 epoxy primer will be applied to the edges to tie in the old and new zinc primers. ABF instructed them to remove the tape and apply the coating properly into the feathered area.

Fabrication on assembled components of the OBG's are not complete. Coating damage requiring re-blast is expected.
