Quality Assurance and Source Inspection

Contract #: 04-0120F4Cty: SF/ALA Rte: 80 PM: 13.2/13.9File #: 69.15**SOURCE INSPECTION REPORT****Resident Engineer:** Pursell, Gary**Address:** 333 Burma Road**City:** Oakland, CA 94607**Report No:** SIR-000604**Date Inspected:** 02-May-2009**Project Name:** SAS Superstructure**OSM Arrival Time:** 0**Prime Contractor:** American Bridge/Fluor Enterprises, a JV**OSM Departure Time:** 12**Contractor:** Zhenhua Port Machinery Company, Ltd (ZPMC), Changxing Island**Location:** Changxing Dao, Shanghai

Quality Control Contact:	ABF Paint Supervisor William (Bill) Oak	Quality Control Present:	Yes	No
Material transfer:	Yes No N/A	Sampled Items:	Yes	No N/A
Stock Transfer:	Yes No N/A	OK to Cut:	Yes	No N/A
Rebar Test Witness:	Yes No N/A	Delayed/Cancelled:	Yes	No N/A
Other:	Surface Preparation and Coatings Application			
Bridge No:	34-0006	Component:	OBG 1BW, 7DE, 7EE, Misc. Metal	
Bid Item:	79, 80, 81	Lot No:	B226

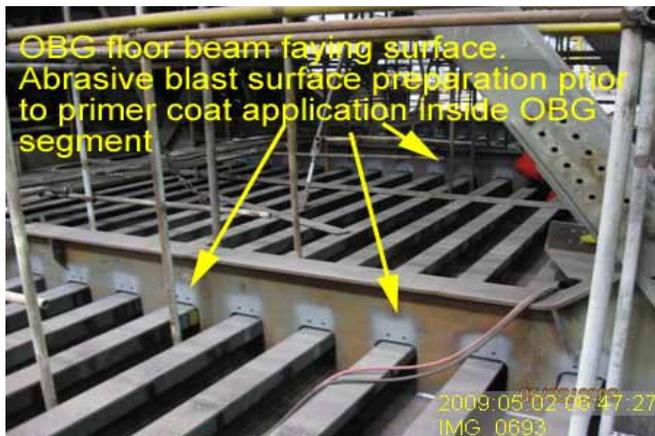
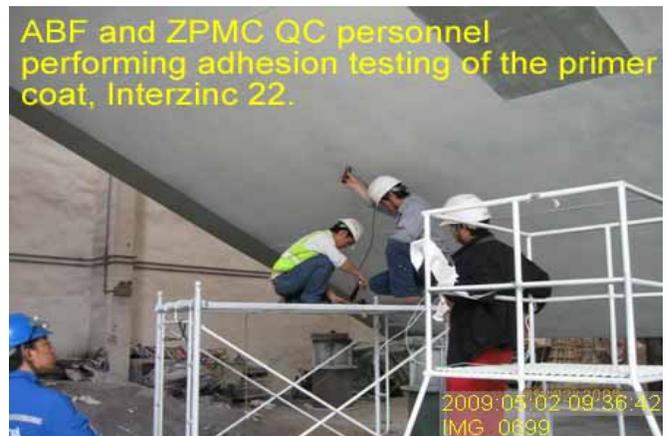
Adhesion testing was performed in accordance with the requirements in ASTM Designation: D 4541. The pull test met the contract requirements of having a minimum adhesion to steel of 4 MPa.

Fabrication on assembled components of the OBG's are not complete. Coating damage requiring re-blast is expected.
