DEPARTMENT OF TRANSPORTATION

Contract #: 04-0120F4Cty: SF/ALA Rte: 80 PM: 13.2/13.9File #: 69.15**SOURCE INSPECTION REPORT****Resident Engineer:** Pursell, Gary**Address:** 333 Burma Road**City:** Oakland, CA 94607**Report No:** SIR-000636**Date Inspected:** 28-May-2009**Project Name:** SAS Superstructure**OSM Arrival Time:** 0**Prime Contractor:** American Bridge/Fluor Enterprises, a JV**OSM Departure Time:** 12**Contractor:** Zhenhua Port Machinery Company, Ltd (ZPMC), Changxing Island **Location:** Changxing Dao, Shanghai

Other: Surface Preparation and Coatings Application**Bridge No:** 34-0006**Component:** OBG 1AAE, Tower L1E**Bid Item:** 77,78,79,80**Lot No:** B226**Summary of Items Observed:**

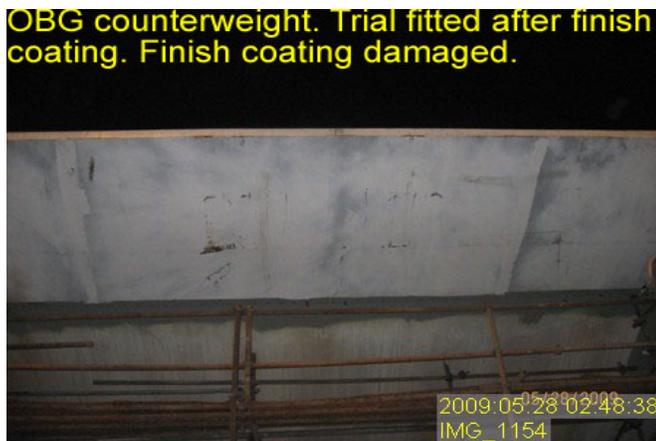
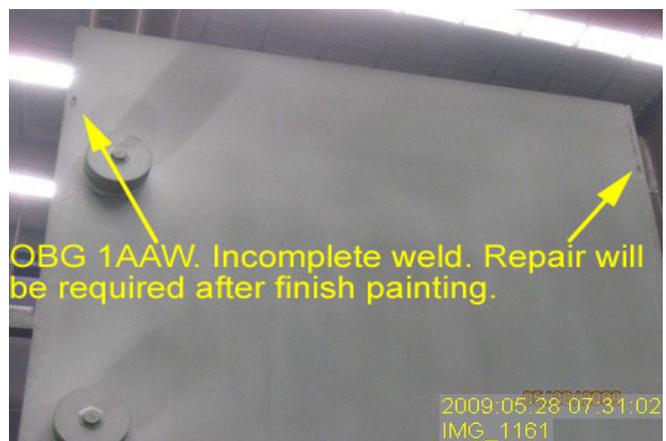
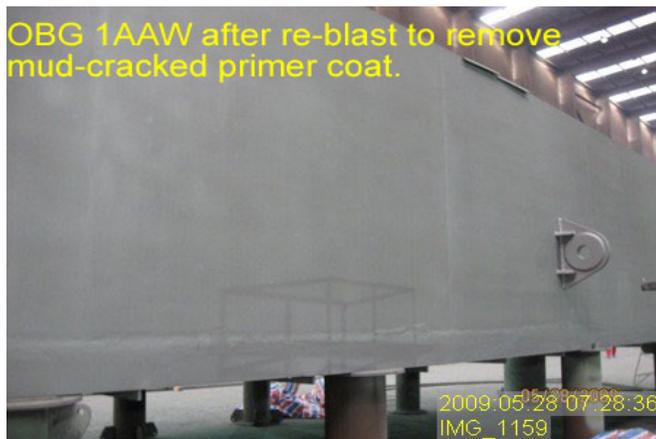
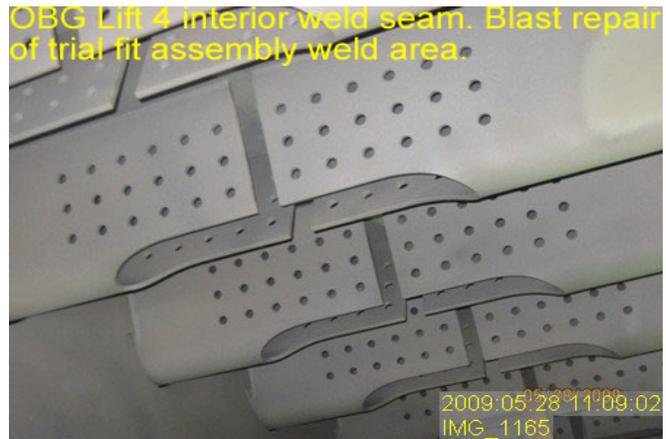
Caltrans QA Coatings Inspectors received a Notice of Inspection to attend a joint inspection with ABF and ZPMC QC for surface preparation by abrasive blasting. Upon entering the confined space area it was observed that the area was not ready for inspection. Rust spots and chalk marks from previous inspections were visible. The inspection was canceled until the blasting is complete.

Caltrans QA Coatings Inspectors received a Notice of Inspection to attend a joint inspection with ABF and ZPMC QC for surface preparation by abrasive blasting. A few spots of grinding were required to remove arc strikes, sharp

edges, dings in the substrate that left sharp edges sticking up, and edge conditioning required by the Project Special Provisions Section 10-1.69. After the grinding was completed the surfaces were re-blasted to meet the SSPC SP10 Near White Metal Contract requirements. Surface profile Testex Tape was used by ZPMC QC personnel to record the blast profile. The Testex tape was measured using a dial micrometer. The readings were within the contract requirements of 40 and 86 microns. Ambient conditions were within Contract required parameters. After the base metal was prepared to meet the contract requirements, Interzinc 22 primer was applied within the specified 8 hour window after the start of abrasive blasting. The coating was mixed under the supervision of International Paint's Onsite Technical Services Engineer Peng Zi Li and QC personnel representing ABF and ZPMC.

Fabrication on assembled components of the OBG's and Towers are not complete. Outstanding weld repairs have not been performed. Coating damage requiring re-blast is expected.
