Contract #: 04-0120F4Cty: SF/ALA Rte: 80 PM: 13.2/13.9File #: 69.28**WELDING INSPECTION REPORT****Resident Engineer:** Pursell, Gary**Address:** 333 Burma Road**City:** Oakland, CA 94607**Report No:** WIR-000037**Date Inspected:** 11-Nov-2006**Project Name:** SAS Superstructure**OSM Arrival Time:** 800**Prime Contractor:** American Bridge/Fluor Enterprises, a JV**OSM Departure Time:** 1730**Contractor:** Zhenhua Port Machinery Company, Ltd (ZPMC), Changxing Island **Location:** Shanghai, China**CWI Name:** Xie Ping**CWI Present:** Yes No**Inspected CWI report:** Yes No N/A**Rod Oven in Use:** Yes No N/A**Electrode to specification:** Yes No N/A**Weld Procedures Followed:** Yes No N/A**Qualified Welders:** Yes No N/A**Verified Joint Fit-up:** Yes No N/A**Approved Drawings:** Yes No N/A**Approved WPS:** Yes No N/A**Delayed / Cancelled:** Yes No N/A**Bridge No:** 34-0006**Component:** N/A**Summary of Items Observed:**

Office of Structural Materials Quality Assurance Inspector (QA), David McClary observed quality control functions related to procedure qualification (PQR) testing at the ZPMC facility in Shanghai, Republic of China for the San Francisco Oakland Bay Self Anchored Suspens

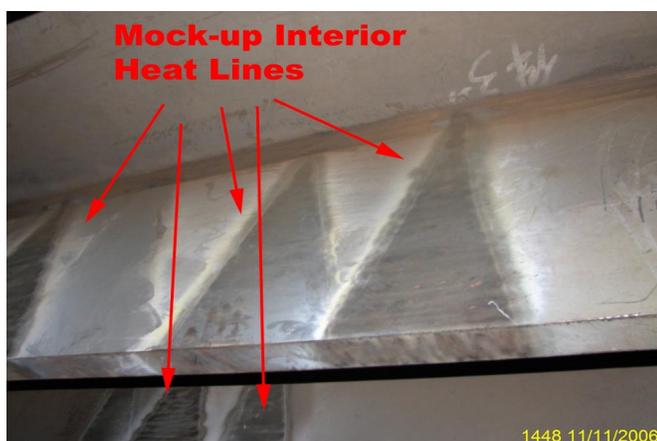
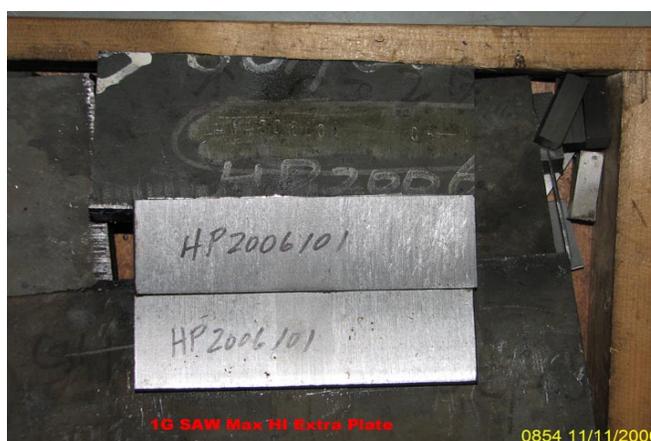
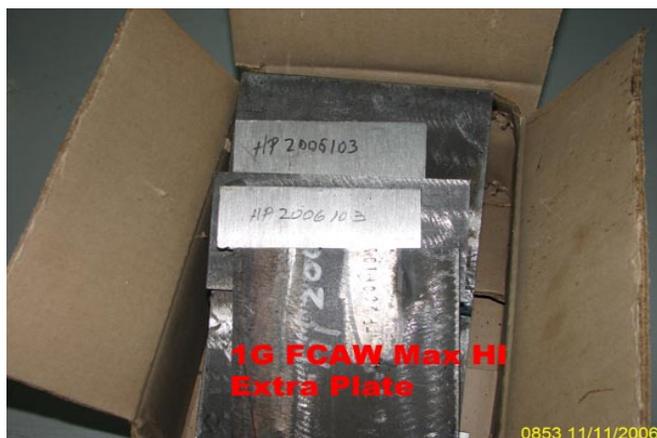
The QA Inspector went inside ZPMC's informational mock-up of the tower to look at locations which present ABF with concerns regarding accessibility. During these observations, QA observed what appears to be telltale signs of heat straightening on many of the components. Since this mock-up is only for ZPMC's information and not the actual mock-up required in the Special Provisions this may just be part of the learning process or could be indicative of ZPMC's intended fabrication practices. See Photos below for typical areas heat straightened on the skin plate stiffeners:
