Contract #: 04-0120F4Cty: SF/ALA Rte: 80 PM: 13.2/13.9File #: 69.28**WELDING INSPECTION REPORT****Resident Engineer:** Pursell, Gary**Address:** 333 Burma Road**City:** Oakland, CA 94607**Report No:** WIR-001303**Date Inspected:** 28-Dec-2006**Project Name:** SAS Superstructure**OSM Arrival Time:** 700**Prime Contractor:** American Bridge/Fluor Enterprises, a JV**OSM Departure Time:** 1500**Contractor:** Zhenhua Port Machinery Company, Ltd (ZPMC), Changxing Island **Location:** Shanghai, China

Bridge No: 34-0006**Component:** OBG**Summary of Items Observed:**

WELDING INSPECTION REPORT

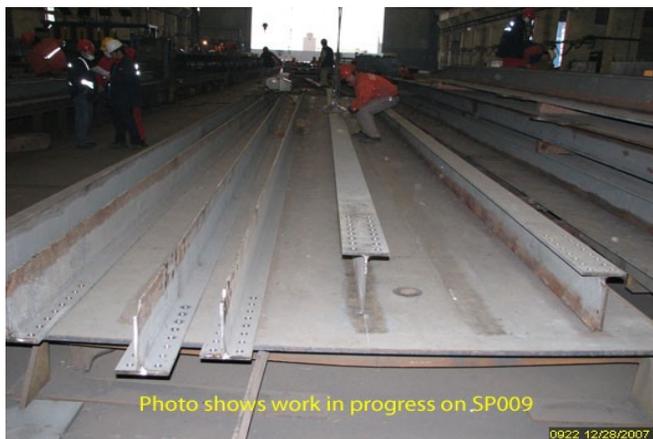
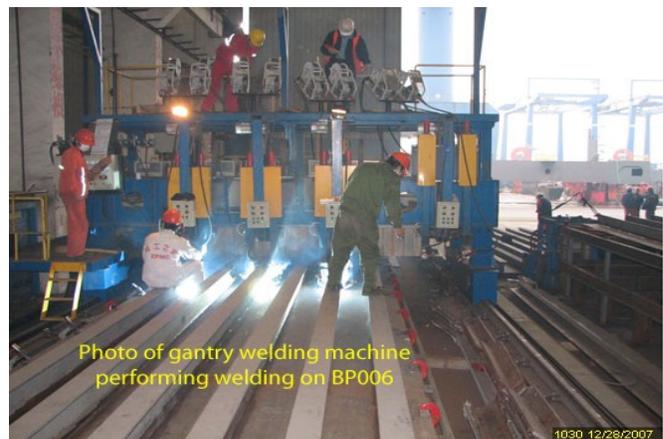
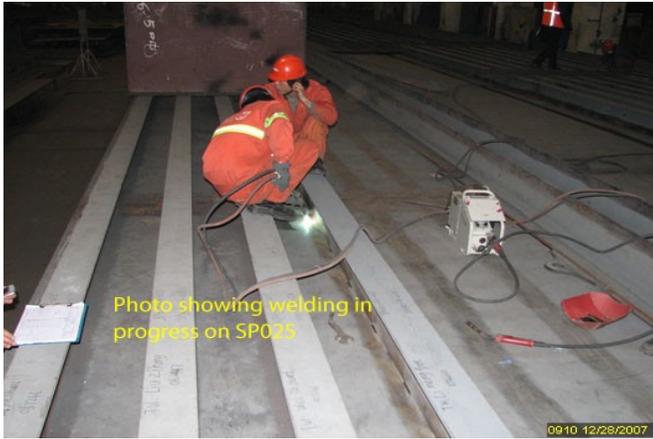
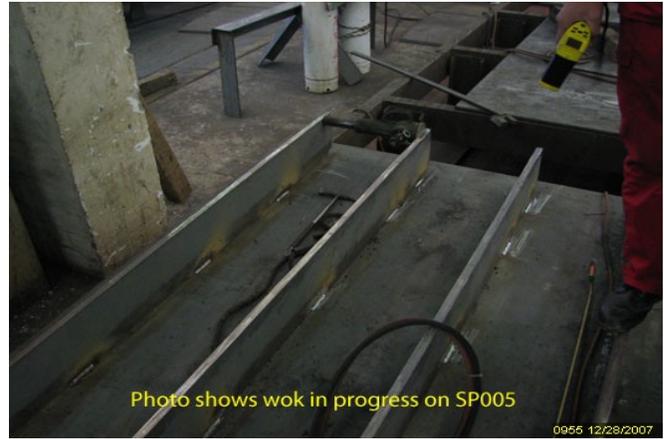
At this stage of fabrication, all items observed by QA Inspector appear to comply with the requirements of the Standard Specifications, contract Special Provisions, approved drawings, Welding Code AWS D1.5 (2002) and approved Welding Procedure Specification. See the following photographs which show work observed and other details.
