DEPARTMENT OF TRANSPORTATION

Contract #: 04-0120F4Cty: SF/ALA Rte: 80 PM: 13.2/13.9File #: 69.28**WELDING INSPECTION REPORT****Resident Engineer:** Pursell, Gary**Address:** 333 Burma Road**City:** Oakland, CA 94607**Report No:** WIR-000059**Date Inspected:** 15-Jan-2007**Project Name:** SAS Superstructure**OSM Arrival Time:** 800**Prime Contractor:** American Bridge/Fluor Enterprises, a JV**OSM Departure Time:** 1700**Contractor:** Zhenhua Port Machinery Company, Ltd (ZPMC), Changxing Island **Location:** Shanghai, China**CWI Name:** Huang Wei**CWI Present:** Yes No**Inspected CWI report:** Yes No N/A**Rod Oven in Use:** Yes No N/A**Electrode to specification:** Yes No N/A**Weld Procedures Followed:** Yes No N/A**Qualified Welders:** Yes No N/A**Verified Joint Fit-up:** Yes No N/A**Approved Drawings:** Yes No N/A**Approved WPS:** Yes No N/A**Delayed / Cancelled:** Yes No N/A**Bridge No:** 34-0006**Component:** Bid 52, 55 Tower and Girder**Summary of Items Observed:**

Office of Structural Materials Quality Assurance Inspector (QA), Mark Wright was present as requested to observe quality control functions related to procedure qualification record (PQR) testing at the ZPMC facility

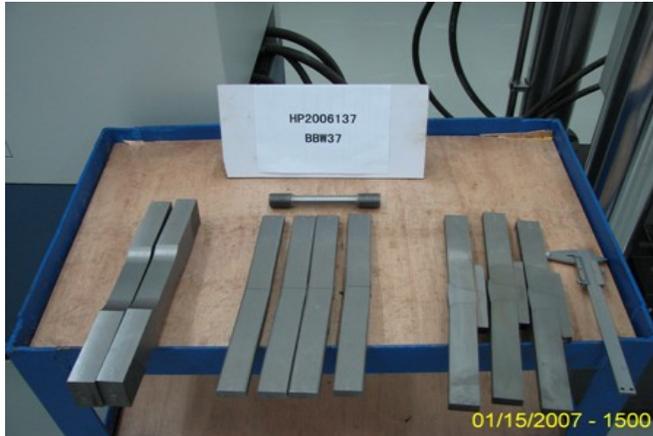
The Caltrans Quality Assurance (QA) Inspector was present as requested to witness the mechanical testing of HP2006137 Procedure Qualification (PQR) test plate. The QA Inspector observed tensile test on reduced sections and all weld metal specimens along with side bends and macro etch test. The test was performed per the AWS D1.5, Section 5.18 requirements. The test appeared not to comply with the contract documents due to the Charpy Vee Notch (CVN) notch was not cut to the correct depth. The ZPMC lab personnel stated that the samples would be removed from another part of the plate and the CVN test would be performed tomorrow.
