**DEPARTMENT OF TRANSPORTATION**

Office of Structural Materials Quality Assurance Inspector (QA), Mark Wright was present as requested to observe quality control functions related to procedure qualification record (PQR) testing at the ZPMC facility in Shanghai, China for the San Francisco Oakland Bay Self Anchored Suspension Bridge.

# WELDING INSPECTION REPORT

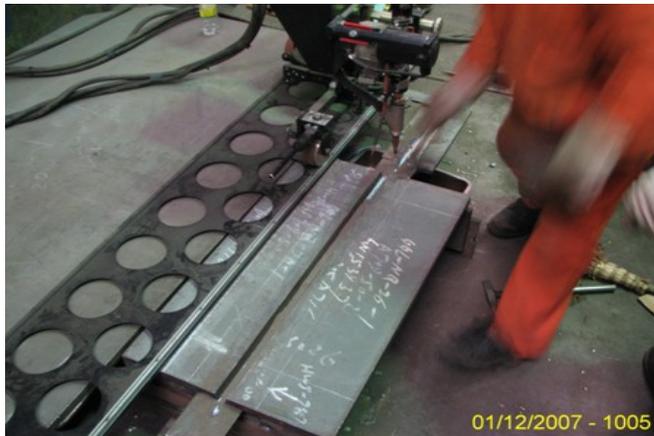
The QA Inspector observed the continuation welding of a Procedure Qualification (PQR) test plate identified as HP-2006137. The HP2006137 test was conducted on A709-50-2 steel, 26mm thick, using Submerged Arc Welding (SAW) 2mm diameter electrode in the 1G (flat) position with a root opening of 10mm to AWS D1.5, Section 5.12 (maximum heat input) with a steel backing. The QA Inspector observed ZPMC Quality Control (QC) recording the essential variable (amps, volts, travel speed) for each pass and randomly verified the parameters using an Amprobe® amperage / voltage meter and a stopwatch. The QA Inspector issued lot number B41-009-07. The welding appeared to comply with the contract documents. Photo below.
