Contract #: 04-0120F4Cty: SF/ALA Rte: 80 PM: 13.2/13.9File #: 69.28**WELDING INSPECTION REPORT****Resident Engineer:** Pursell, Gary**Address:** 333 Burma Road**City:** Oakland, CA 94607**Report No:** WIR-000082**Date Inspected:** 10-Feb-2007**Project Name:** SAS Superstructure**OSM Arrival Time:** 1200**Prime Contractor:** American Bridge/Fluor Enterprises, a JV**OSM Departure Time:** 1700**Contractor:** Zhenhua Port Machinery Company, Ltd (ZPMC), Changxing Island **Location:** Shanghai, China**CWI Name:** Zhou Daqing**CWI Present:** Yes No**Inspected CWI report:** Yes No N/A**Rod Oven in Use:** Yes No N/A**Electrode to specification:** Yes No N/A**Weld Procedures Followed:** Yes No N/A**Qualified Welders:** Yes No N/A**Verified Joint Fit-up:** Yes No N/A**Approved Drawings:** Yes No N/A**Approved WPS:** Yes No N/A**Delayed / Cancelled:** Yes No N/A**Bridge No:** 34-0006**Component:** welder Qualifications**Summary of Items Observed:**

Office of Structural Materials Quality Assurance Inspector (QA), Mark Wright was present as requested to observe quality control functions related to procedure qualification record (PQR) testing at the ZPMC facility in Shanghai, China for the San F

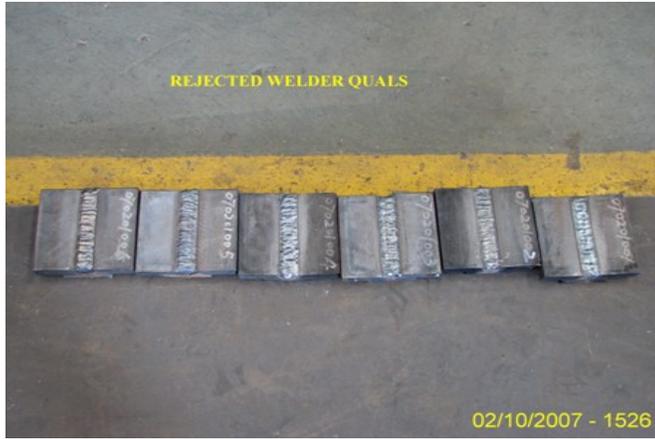
The Caltrans Quality Assurance (QA) Inspector was present to observe the welder qualifications being conducted at ZPMC. The QA observed that Moody International was conducting the Certified Welding Inspector (CWI) functions. The QA also observed that the 6 welders being tested were running out of parameters of the posted welding procedure specifications (WPS). The travel speed was too low for the WPS specified speed. The welders also performed a wide weave weld cap which was measured to be outside of the size stated in the code book. As shown in the photo below.
