DEPARTMENT OF TRANSPORTATION

Quality Assurance and Source Inspection

Contract #: 04-0120F4Cty: SF/ALA Rte: 80 PM: 13.2/13.9File #: 69.28**WELDING INSPECTION REPORT****Resident Engineer:** Pursell, Gary**Address:** 333 Burma Road**City:** Oakland, CA 94607**Report No:** WIR-000095**Date Inspected:** 15-Mar-2007**Project Name:** SAS Superstructure**OSM Arrival Time:** 800**Prime Contractor:** American Bridge/Fluor Enterprises, a JV**OSM Departure Time:** 1730**Contractor:** Zhenhua Port Machinery Company, Ltd (ZPMC), Changxing Island **Location:** Shanghai, China**CWI Name:** Liu Liu**CWI Present:** Yes No**Inspected CWI report:** Yes No N/A**Rod Oven in Use:** Yes No N/A**Electrode to specification:** Yes No N/A**Weld Procedures Followed:** Yes No N/A**Qualified Welders:** Yes No N/A**Verified Joint Fit-up:** Yes No N/A**Approved Drawings:** Yes No N/A**Approved WPS:** Yes No N/A**Delayed / Cancelled:** Yes No N/A**Bridge No:** 34-0006**Component:** Bid: 52, 55 Tower & Girder**Summary of Items Observed:**

WELDING INSPECTION REPORT

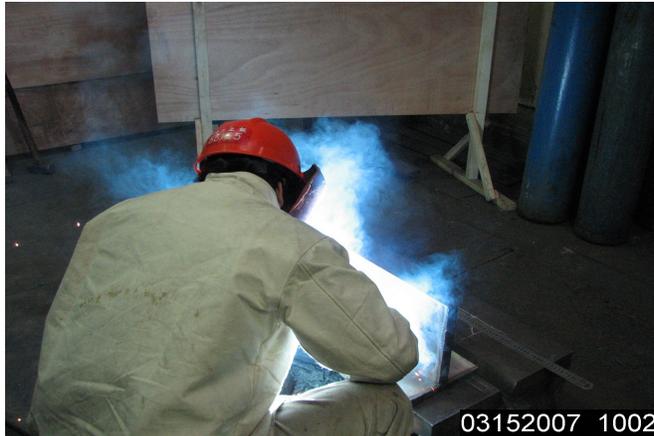
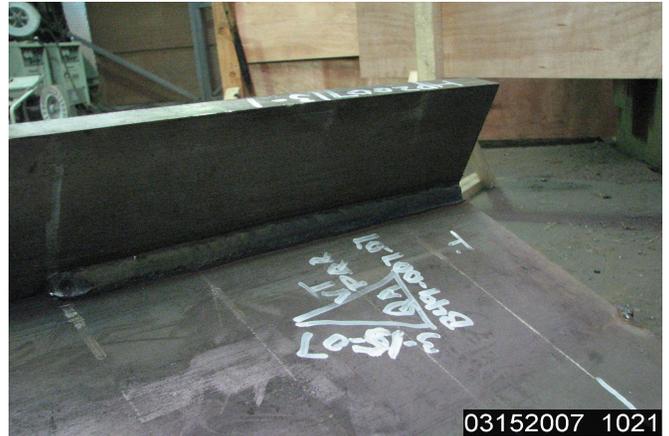
1

Caltrans Quality Assurance (QA) Inspector was present to witness procedure qualification (PQR) retesting for HP200713-1 as requested by ZPMC. The test plate was welded in the 2F (horizontal) position, using the flux core arc welding (FCAW) semi-automatic welding process. The test consisted of a minimum multi pass weld. The welding consumable (electrode) is identified as specification E71T1-1, classification AWS A5.20 and 1.4 mm diameter. The welding was performed in accordance with AWS D1.5, Section 5.10.3 fillet weld soundness requirements. The welding appeared to comply with the contract documents. See Caltrans Welding Witness Report (TL-6032), dated March 15, 2007 for additional information. Caltrans QA Inspector assigned lot number B49-007-07 for minimum multi pass weld.

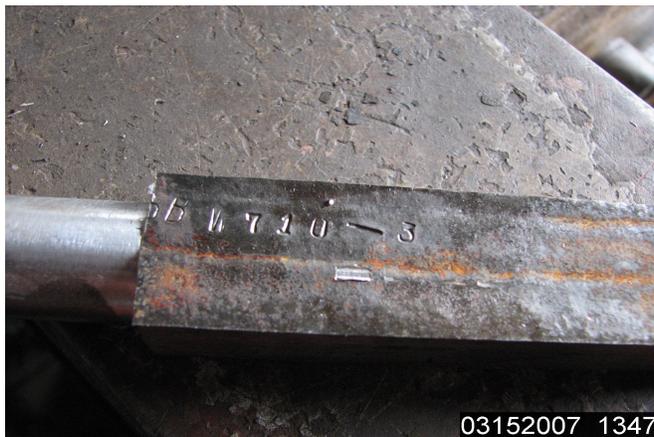
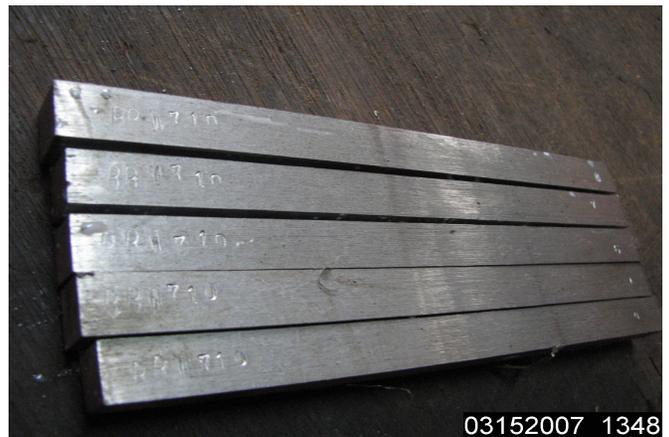
2

Caltrans QA inspector observed machining of the mechanical test specimens for welding procedure HP200710 at Shan Xun Gong Mao Machine Company and was accompanied by ZPMC QA Inspector, Mr. Liu Jian Hua. Caltrans QA inspector observed that the mechanical test sampling was being performed to AWS D1.5, Figure 5.1. The welding procedure was performed to AWS D1.5, paragraph 5.13. This calls out the machining of the mechanical test samples to Figure 5.3. Caltrans Quality Assurance Inspector (QA) spoke with ABF welding engineer Craig Knops regarding the machining of PQR HP-200710. Caltrans QA inspector had observed that they appeared to be machining the plate as though it was performed to AWS D1.5, Figure 5.1 which includes All Weld Metal Tension (AWMT) and Charpy-V notch samples. The welding was actually performed to AWS D1.5, Figure 5.3 for weld soundness and does not require either the AWMT or Charpy samples. Mr. Knops spoke with ZPMC Testing Center Director Mr. Liu Liu about this and was informed that this was due to miscommunication with the Machine Shop, and that ZPMC did not intend to test either the AWMT or Charpy samples.

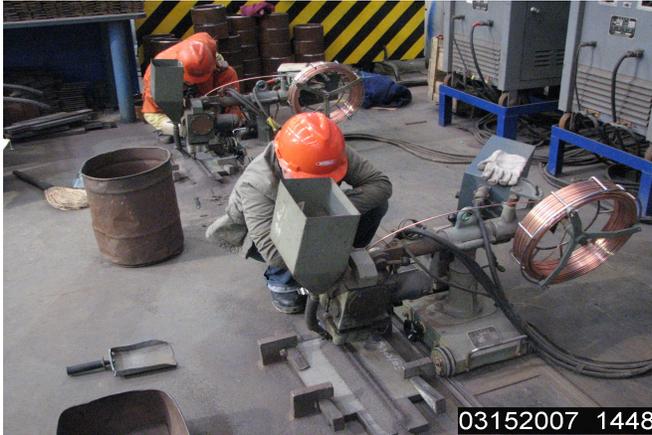
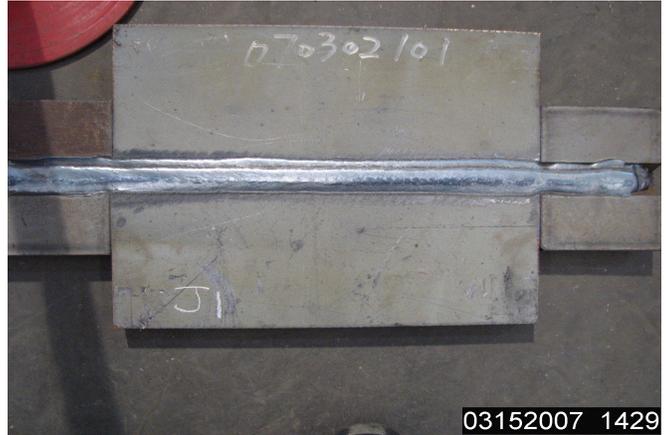
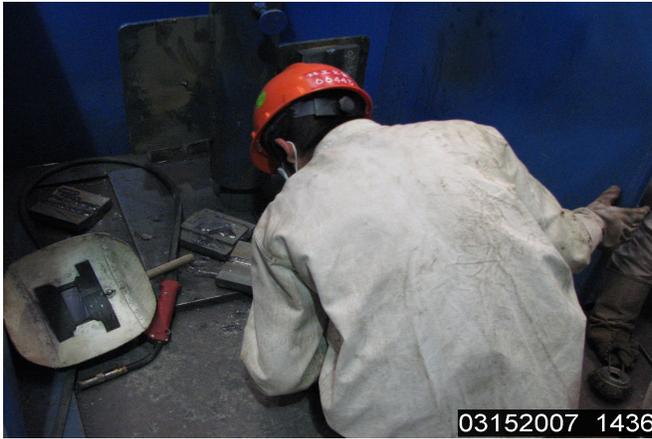
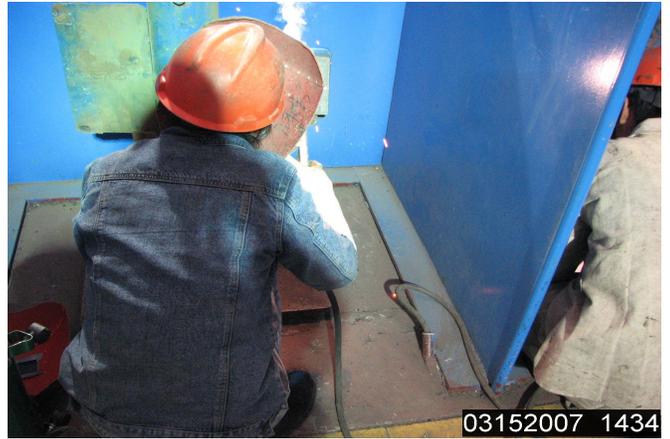
3

Caltrans QA inspector observed welder and welder operator qualification testing being performed at ZPMC testing center. American Bridge/Fluor (ABF) representative, Mr. David Williams submitted a welder qualification list stating the names of the welders and welding processes. The list called out seven (7) submerged arc welding (SAW) welder operators, thirty (30) shield metal arc welding (SMAW) welders and thirteen (13) flux core arc welding (FCAW) welders for testing. Caltrans QA inspector observed Moody International Inspection conduction welder qualification tests. Caltrans QA inspector observed SAW welder operators performing 1G test in the flat position, SMAW welders performing 3G welder qualification test in the vertical position and FCAW welders performing 3G welder qualification testing in the vertical position. The testing appeared to be performed in conformance AWS D1.5

requirements.
