**DEPARTMENT OF TRANSPORTATION**

Contract #: 04-0120F4Cty: SF/ALA Rte: 80 PM: 13.2/13.9File #: 69.28**WELDING INSPECTION REPORT****Resident Engineer:** Pursell, Gary**Address:** 333 Burma Road**City:** Oakland, CA 94607**Report No:** WIR-000137**Date Inspected:** 25-Apr-2007**Project Name:** SAS Superstructure**OSM Arrival Time:** 800**Prime Contractor:** American Bridge/Fluor Enterprises, a JV**OSM Departure Time:** 1730**Contractor:** Zhenhua Port Machinery Company, Ltd (ZPMC), Changxing Island **Location:** Shanghai, China**CWI Name:** Huang Wei**CWI Present:** Yes No**Inspected CWI report:** Yes No N/A**Rod Oven in Use:** Yes No N/A**Electrode to specification:** Yes No N/A**Weld Procedures Followed:** Yes No N/A**Qualified Welders:** Yes No N/A**Verified Joint Fit-up:** Yes No N/A**Approved Drawings:** Yes No N/A**Approved WPS:** Yes No N/A**Delayed / Cancelled:** Yes No N/A**Bridge No:** 34-0006**Component:** N/A**Summary of Items Observed:**

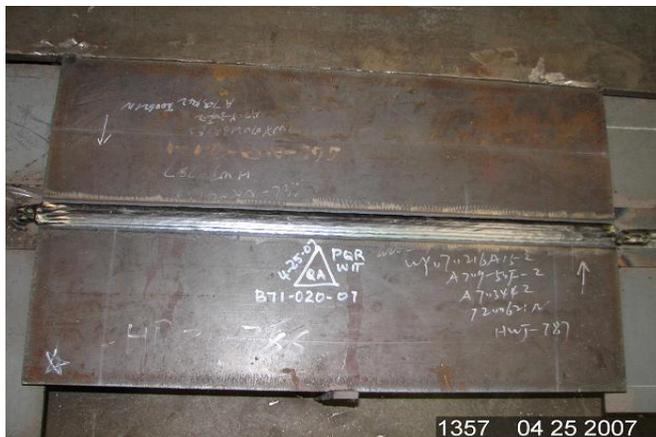
The CALTRANS Quality Assurance (QA) Inspector, Alfredo Acuna was present for the welding qualification testing pertinent for the welding qualification record (PQR) HP200786 scheduled for this project. ZPMC, welding operator Zhang Xing Jin and Jiang Xiao Hu were observed by the QA Inspector performing welding operations following the preliminary welding procedure specification PWPS-B-T-2221-FB-2 for the PQR identified as HP200786. Base metal was designated as A-709-50F-2 (Heat # 7200621N) and appeared to meet the fracture critical requirements. The root opening of the joint was approximately 16 mm. ZPMC followed AWS 5.12.2 Minimum Heat Input procedure WPS using the automatic submerged arc welding (SAW) process in the flat (1G) position with the 4.8 mm diameter EH14 electrode with the S-737 flux. The QA Inspector verified amperages, voltages, travel speeds, preheat and heat interpass temperatures. The QA inspectors recorded welding parameters for a total of 6 passes. The QA inspectors observed that the welding parameters taken by ZPMC QA inspector Hu Gang and Huang Wei appeared to be accurate and in accordance with the contract documents. The QA inspector performed final visual examination to the test coupon after completion. The QA inspector observed that welds appeared to be in general compliance with the contract documents. The QA inspector assigned a lot # B71-020-07 on this date. The digital photograph below shows the PQR test coupon.
