**DEPARTMENT OF TRANSPORTATION**

Contract #: 04-0120F4Cty: SF/ALA Rte: 80 PM: 13.2/13.9File #: 69.28**WELDING INSPECTION REPORT****Resident Engineer:** Pursell, Gary**Address:** 333 Burma Road**City:** Oakland, CA 94607**Report No:** WIR-000403**Date Inspected:** 07-Sep-2007**Project Name:** SAS Superstructure**OSM Arrival Time:** 2330**Prime Contractor:** American Bridge/Fluor Enterprises, a JV**OSM Departure Time:** 800**Contractor:** Zhenhua Port Machinery Company, Ltd (ZPMC), Changxing Island **Location:** Shanghai, China

**Bridge No:** 34-0006**Component:** Mock-Up**Summary of Items Observed:**

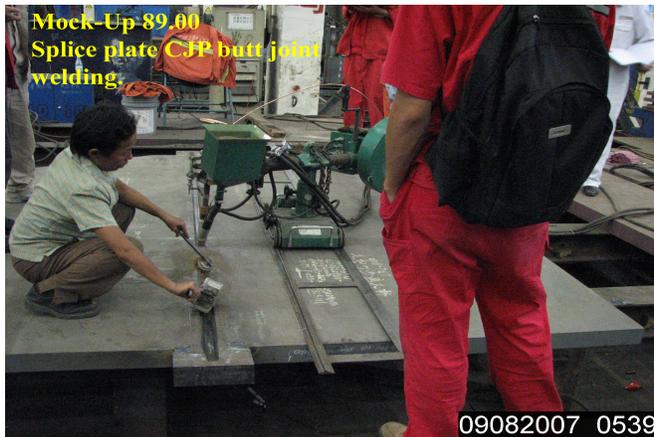
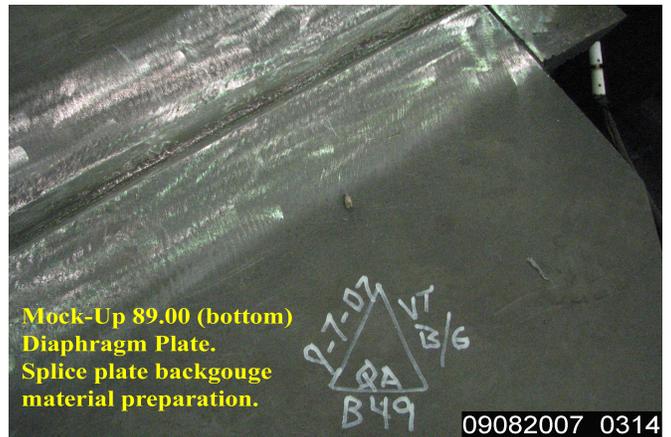
Item	Description	WBS	Dwg No.	Status
1	Diaphragm Plate (bottom)	NA	NA	Work In Progress
	Mock-Up 89.00, Diaphragm (bottom plate): Caltrans QA Inspector observed submerged arc welding (SAW) in progress at plate splice weld, piecemark, P213 to P1235. The approved welder operator is observed welding a complete joint penetration (CJP) fill pass weld in the flat position. Prior to welding of the splice weld butt joint. ZPMC QA inspector, Mr. Shen Xue Jun notified Caltrans QA Inspector that the backgouge weld preparation has been completed and visually inspected and accepted for compliance by ZPMC QC department inspector Mr. Chan Tan. Caltrans QA visually inspected the weld backgouge material prep and concurred with ZPMC acceptance. This assembly was then partially welded out from one side and then flipped over and welded from the other side, per fabrication procedure, welding sequence requirement. Welder is identified as Mr. Wu Zhi Bin. The welder is using welding procedure specification WPS-B-T-3221-B-U3c-S, Revision 1. Caltrans QA measured current welding parameters at approximately 575 amps, 30 volts and travel speed, 480 millimeters per minute (mm/min). Preheat and interpass temperatures were verified during welding activities. Preheat temperature prior to the start of welding measures more than 180 degrees Celsius (350 degree Fahrenheit) but less than 232 degrees Celsius (450 degrees Fahrenheit) during maximum interpass temperature verification. SAW consumables were verified and identified as LA85, classification ENi5, diameter 4.8 mm (.189 inches) electrode and, Mil800-HPNi, classification F9A4 flux. Following digital pictures illustrate butt weld backgouge prep and welding in progress.
