Contract #: 04-0120F4Cty: SF/ALA Rte: 80 PM: 13.9/14.3,0.0/1.6File #: 69.28**WELDING INSPECTION REPORT****Resident Engineer:** Pursell, Gary**Address:** 333 Burma Road**City:** Oakland, CA 94607**Report No:** WIR-000834**Date Inspected:** 15-Nov-2007**Project Name:** SAS Superstructure**OSM Arrival Time:** 2300**Prime Contractor:** American Bridge/Fluor Enterprises, a JV**OSM Departure Time:** 730**Contractor:** Zhenhua Port Machinery Company, Ltd (ZPMC), Changxing Island **Location:** Shanghai, China**CWI Name:** Xu Lefeng**CWI Present:** Yes No**Inspected CWI report:** Yes No N/A**Rod Oven in Use:** Yes No N/A**Electrode to specification:** Yes No N/A**Weld Procedures Followed:** Yes No N/A**Qualified Welders:** Yes No N/A**Verified Joint Fit-up:** Yes No N/A**Approved Drawings:** Yes No N/A**Approved WPS:** Yes No N/A**Delayed / Cancelled:** Yes No N/A**Bridge No:** 34-0006**Component:** Caltrans Mock-Up**Summary of Items Observed:**

WELDING INSPECTION REPORT

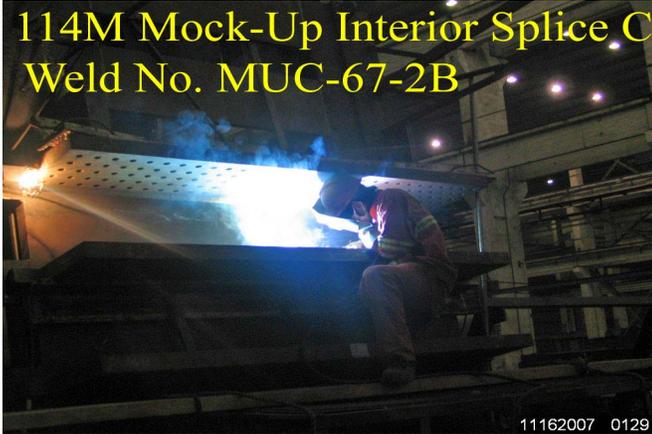
114M Mock-Up Interior Splice C
Weld No. MUC-67-2B

Caltrans QA Inspector observed the welding of Piece Mark p920-9 stiffener to Piece Mark A67 for the 114M Mock-Up Interior Splice Assembly. This weld is identified as MUC-A67-2B. The welder was Jiang Zhou (Welder I.D. No. 040261). The Caltrans QA Inspector also observed the welding of Piece Mark p920-2 stiffener to Piece Mark A75 for the 114M Mock-Up Interior Splice Assembly. This weld is identified as MUC-A75-2A. The welder was Tao Qian (Welder I.D. No. 040457). Welding Procedure Specification (WPS) B-T-2231-TC-U5-F, Revision 1, for Flux Cored Arc Welding (FCAW) was being used for both welds. ZPMC American Welding Society (AWS) Certified Welding Inspector (CWI), Xu Lefeng (CWI No. 07031411) and Bureau Veritas Inspector, Hua Li Wei were present during this welding. The QA Inspector verified compliance with the WPS in the following areas using visual observation, calibrated Fluke ammeter, Tempil stick, tape measure and stop watch, as applicable.
