DEPARTMENT OF TRANSPORTATION

Quality Assurance and Source Inspection

Contract #: 04-0120F4Cty: SF/ALA Rte: 80 PM: 13.9/14.3,0.0/1.6File #: 69.28**WELDING INSPECTION REPORT****Resident Engineer:** Pursell, Gary**Address:** 333 Burma Road**City:** Oakland, CA 94607**Report No:** WIR-000855**Date Inspected:** 13-Nov-2007**Project Name:** SAS Superstructure**OSM Arrival Time:** 630**Prime Contractor:** American Bridge/Fluor Enterprises, a JV**OSM Departure Time:** 1530**Contractor:** Zhenhua Port Machinery Company, Ltd (ZPMC), Changxing Island **Location:** Shanghai, China**CWI Name:** Li Zhi jiang**CWI Present:** Yes No**Inspected CWI report:** Yes No N/A**Rod Oven in Use:** Yes No N/A**Electrode to specification:** Yes No N/A**Weld Procedures Followed:** Yes No N/A**Qualified Welders:** Yes No N/A**Verified Joint Fit-up:** Yes No N/A**Approved Drawings:** Yes No N/A**Approved WPS:** Yes No N/A**Delayed / Cancelled:** Yes No N/A**Bridge No:** 34-0006**Component:** OBG**Summary of Items Observed:**

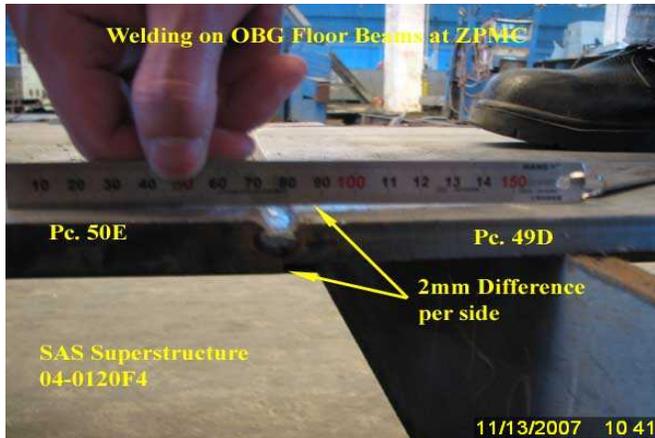
Caltrans QA Inspector observed ZPMC welder, Liu Long xian, certification number 044786 depositing filler metal, on a Complete Joint Penetration (CJP) weld number 1, using the Flux Cored Arc Welding (FCAW) process, with the guidelines of Welding Procedure Specification (WPS) WPS-B-T-2231-BU2-P1, on floor beam sections for OBG. The related drawing number is FB003-025-001, and piece numbers include 48C (12mm), 50E (16mm) and 49D (12mm). The QA inspector did not witness the fit up of the three plates, however he did notice plates 48C and 49D, which are 12mm in thickness, were centered on 50E, which is 16mm in thickness. This fit up, by design, has 2mm difference per side between the larger and the smaller plates. The QA Inspector also witnessed ZPMC Certified Welding Inspector (CWI), Li Zhi jiang, monitoring all related welding activities and ZPMC Quality Control (QC) Inspector, Zhu Tiam shu, monitoring and recording related welding parameters. In addition QA inspectors randomly monitored welding activities and also recorded related welding parameters. His findings are as follows, amps 255 to 285, volts 27.4 to 29.5, and a travel speed of 570mm per minute. It appears to this QA inspector all related welding activities comply with applicable codes, standards and specifications.
