Contract #: 04-0120F4Cty: SF/ALA Rte: 80 PM: 13.2/13.9File #: 69.28**WELDING INSPECTION REPORT****Resident Engineer:** Pursell, Gary**Address:** 333 Burma Road**City:** Oakland, CA 94607**Report No:** WIR-001170**Date Inspected:** 03-Jan-2008**Project Name:** SAS Superstructure**OSM Arrival Time:** 830**Prime Contractor:** American Bridge/Fluor Enterprises, a JV**OSM Departure Time:** 1730**Contractor:** Zhenhua Port Machinery Company, Ltd (ZPMC), Changxing Island **Location:** Shanghai, China**CWI Name:** See Below**CWI Present:** Yes No**Inspected CWI report:** Yes No N/A**Rod Oven in Use:** Yes No N/A**Electrode to specification:** Yes No N/A**Weld Procedures Followed:** Yes No N/A**Qualified Welders:** Yes No N/A**Verified Joint Fit-up:** Yes No N/A**Approved Drawings:** Yes No N/A**Approved WPS:** Yes No N/A**Delayed / Cancelled:** Yes No N/A**Bridge No:** 34-0006**Component:** Tower and OBG Fabrication**Summary of Items Observed:**

Orthotropic Box Girder (OBG) and Tower Mock Up:

## WELDING INSPECTION REPORT

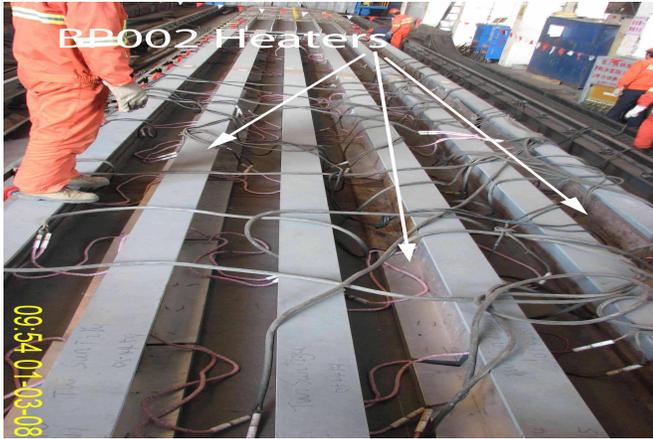
The QA Inspector observed three ZPMC welders using welding procedure specification WPS-B-T-2132-3 using the flux cored welding process for fillet welds on six OBG PL34A base plate BP002 stiffener welds at the same time. ZPMC has multiple flux cored welding manipulators attached to a movable gantry that runs on a track along the length of the stiffener plates. The QA Inspector observed a welding travel speed of approximately 445 mm per minute. As the welding commences, each of the welders is responsible for two of the flux cored welding heads. All welders are using 1.4 mm diameter E71T-1 rolls of electrodes that have been marked as being installed earlier today. The QA Inspector observed all six welding machines have a shielding gas flow between 18 and 20 liters per minute as required by the WPS. Welder Mr. Li Menqian stencil 54460 completed weld BP002-01-010 with a welding current of approximately 300 amps and 29.3 volts and weld BP002-01-011 with a welding current of approximately 305 amps and 28.7 volts. Welder Mr. Xin Meng stencil 53742 completed weld BP002-01-014 with a welding current of approximately 295 amps and 30.1 volts and weld BP002-01-015 with a welding current of approximately 300 amps and 29.5 volts. Welder Mr. Li Shuliang stencil 48801 completed weld BP002-01-016 with a welding current of approximately 302 amps and 29.6 volts and weld BP002-01-017 with a welding current of approximately 305 amps and 30.0 volts. See the photograph below showing where ZPMC personnel placed electric heaters to preheat the base material. Items observed by the QA Inspector appear to comply with project specifications.
