Contract #: 04-0120F4Cty: SF/ALA Rte: 80 PM: 13.2/13.9File #: 69.28**WELDING INSPECTION REPORT****Resident Engineer:** Pursell, Gary**Address:** 333 Burma Road**City:** Oakland, CA 94607**Report No:** WIR-001249**Date Inspected:** 17-Jan-2008**Project Name:** SAS Superstructure**OSM Arrival Time:** 800**Prime Contractor:** American Bridge/Fluor Enterprises, a JV**OSM Departure Time:** 1800**Contractor:** Zhenhua Port Machinery Company, Ltd (ZPMC), Changxing Island **Location:** Shanghai, China**CWI Name:** See Below**CWI Present:** Yes No**Inspected CWI report:** Yes No N/A**Rod Oven in Use:** Yes No N/A**Electrode to specification:** Yes No N/A**Weld Procedures Followed:** Yes No N/A**Qualified Welders:** Yes No N/A**Verified Joint Fit-up:** Yes No N/A**Approved Drawings:** Yes No N/A**Approved WPS:** Yes No N/A**Delayed / Cancelled:** Yes No N/A**Bridge No:** 34-0006**Component:** Tower and OBG Fabrication**Summary of Items Observed:**

Orthotropic Box Girder (OBG) and Tower Mock Up:

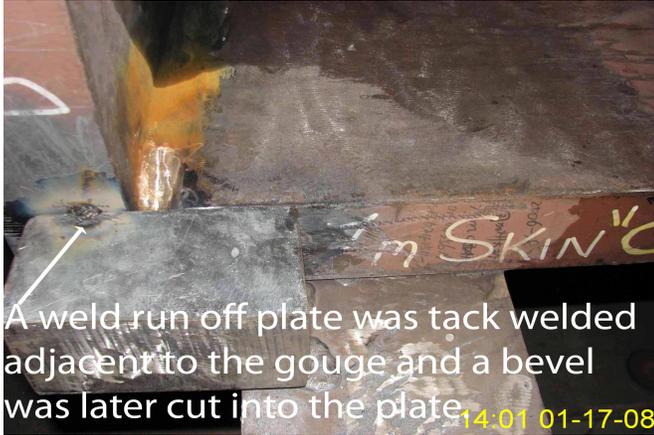
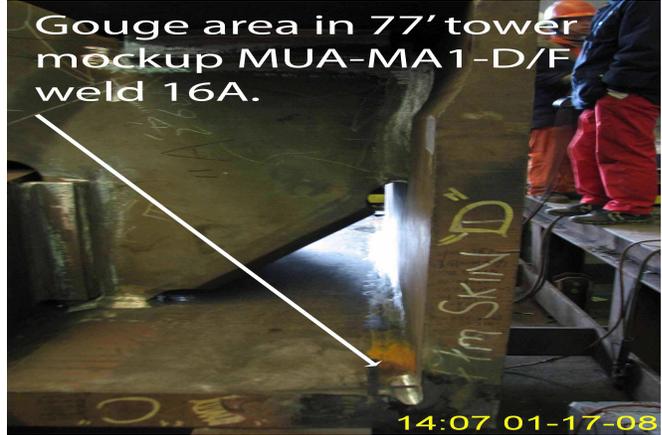
The QA Inspector observed ZPMC personnel performing carbon air arc gouging of weld material at both ends of the 77' tower mockup MUA-MA1-D/F weld 16A. Following the completion of the gouging ZPMC personnel used an electric grinder to obtain a bright metal surface. The QA Inspector measured the gouge on the west end of the weld to be approximately 32 mm deep x 70 mm long and 33 mm wide. The gouge on the east end of the weld

is approximately 25 mm deep x 65 mm long and 33 mm wide. ZPMC then installed weld extension plates at the ends of the welds and the base material was then heated with electric heating elements that were attached to the base material. The QA Inspector did not observe ZPMC personnel performing welding repairs of weld 16A. See the photograph below that shows the east gouge and a run off plate that has been tack welded adjacent to the gouge.
