Contract #: 04-0120F4Cty: SF/ALA Rte: 80 PM: 13.2/13.9File #: 69.28**WELDING INSPECTION REPORT****Resident Engineer:** Pursell, Gary**Address:** 333 Burma Road**City:** Oakland, CA 94607**Report No:** WIR-001413**Date Inspected:** 29-Jan-2008**Project Name:** SAS Superstructure**OSM Arrival Time:** 900**Prime Contractor:** American Bridge/Fluor Enterprises, a JV**OSM Departure Time:** 1430**Contractor:** Zhenhua Port Machinery Company, Ltd (ZPMC), Changxing Island **Location:** Shanghai, China**CWI Name:** See Below**CWI Present:** Yes No**Inspected CWI report:** Yes No N/A**Rod Oven in Use:** Yes No N/A**Electrode to specification:** Yes No N/A**Weld Procedures Followed:** Yes No N/A**Qualified Welders:** Yes No N/A**Verified Joint Fit-up:** Yes No N/A**Approved Drawings:** Yes No N/A**Approved WPS:** Yes No N/A**Delayed / Cancelled:** Yes No N/A**Bridge No:** 34-0006**Component:** Tower and OBG Fabrication**Summary of Items Observed:**

Orthotropic Box Girder (OBG) and Tower Mock Up:

WELDING INSPECTION REPORT

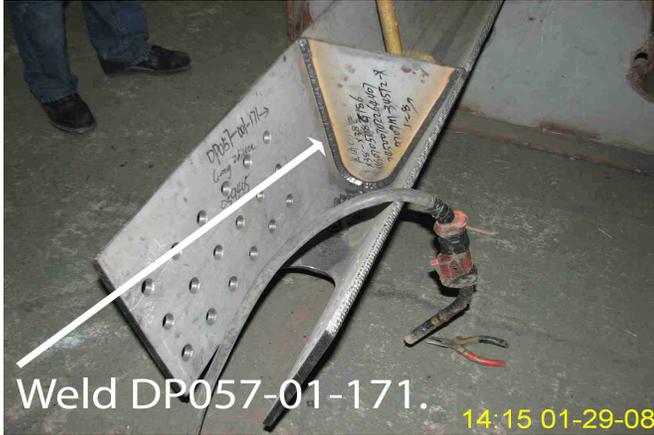
QA Inspector observed ZPMC welder Mr. Hong Zhi Wu stencil 59457 is using welding procedure specification WPS-B-T-2133 using the flux cored welding process for fillet welds on OBG closed rib weld DP057-001-171. The QA Inspector observed a welding current of approximately 200 amps, 24.0 volts and the base material has a minimum preheat temperature of 10° C. Items observed by the QA Inspector appear to comply with project

specifications. See the photograph below for additional information.

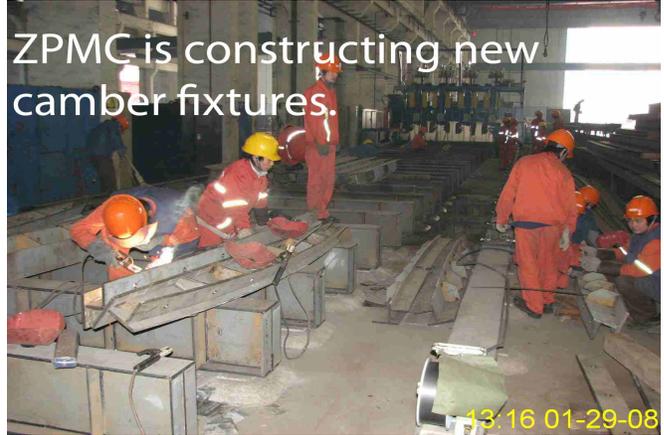
ZPMC personnel are constructing additional camber fixtures that are to be used for securing orthotropic box girder side plates during completion of the stiffener plate welding, and no ZPMC personnel were observed to be welding Caltrans components in bay 3. See the photograph of ZPMC personnel constructing the new camber fixtures.
