Contract #: 04-0120F4Cty: SF/ALA Rte: 80 PM: 13.2/13.9File #: 69.28**WELDING INSPECTION REPORT****Resident Engineer:** Pursell, Gary**Address:** 333 Burma Road**City:** Oakland, CA 94607**Report No:** WIR-001426**Date Inspected:** 27-Jan-2008**Project Name:** SAS Superstructure**OSM Arrival Time:** 900**Prime Contractor:** American Bridge/Fluor Enterprises, a JV**OSM Departure Time:** 1400**Contractor:** Zhenhua Port Machinery Company, Ltd (ZPMC), Changxing Island **Location:** Shanghai, China**CWI Name:** Zhang Zhong**CWI Present:** Yes No**Inspected CWI report:** Yes No N/A**Rod Oven in Use:** Yes No N/A**Electrode to specification:** Yes No N/A**Weld Procedures Followed:** Yes No N/A**Qualified Welders:** Yes No N/A**Verified Joint Fit-up:** Yes No N/A**Approved Drawings:** Yes No N/A**Approved WPS:** Yes No N/A**Delayed / Cancelled:** Yes No N/A**Bridge No:** 34-0006**Component:** OBG**Summary of Items Observed:**

WELDING INSPECTION REPORT

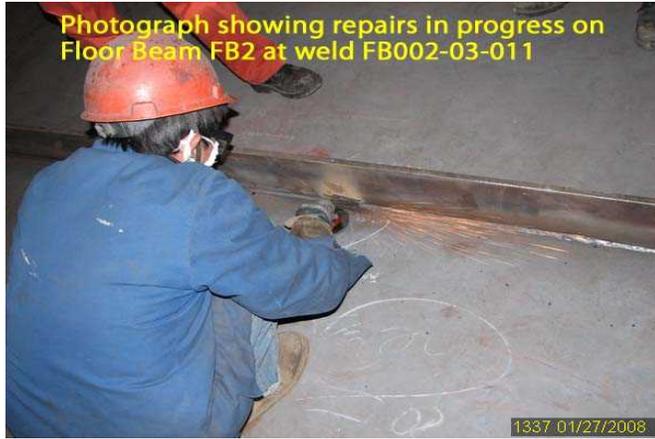
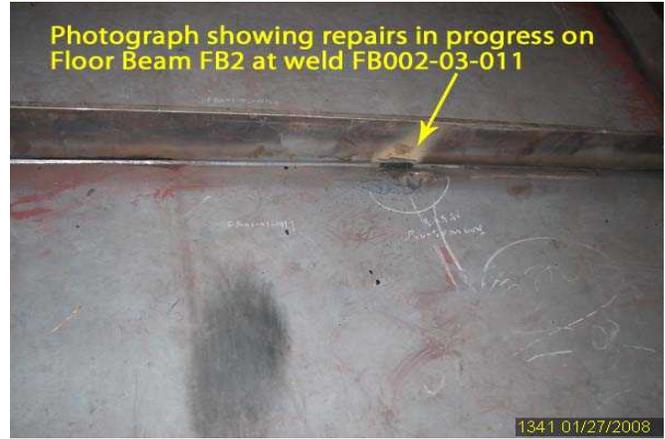
Bay 7- QA Inspector randomly observed ZPMC qualified welder Ma Mingfu ID #056375 utilizing the Shielded Metal Arc Welding (SMAW) process per the approved Welding Repair Procedure #B-WR052 and Welding Procedure Specification (WPS) number WPS-345-SMAW-2G(2F) Repair while performing weld repairs to Floor Beam FB2. QA Inspector observed that repair welding on FB2 at weld joint FB002-03-011 was monitored by QC Inspector Zhang Zhong. QA Inspector observed welding and preheating parameters are within the parameters of the WPS and recorded them as follows: welding amperage 167 amps, welding voltage 24 volts. Preheat temperature is verified by QA Inspector at 72° Celsius prior to welding. The weld parameters appeared to comply with contract requirements and the approved WPS.

Bay 7- QA Inspector Gabriel Quintana performed numerous measurements on fourteen Floor Beams as requested by the Engineer. QA Inspector Paul Dawson recorded these measurements performed by QA Inspector Gabriel Quintana. Measurements of the stiffeners included weld hold back at the weld terminations and snipe hole dimensions. The data collected when complete will be forwarded to the requesting Engineer.
