**DEPARTMENT OF TRANSPORTATION**

Contract #: 04-0120F4Cty: SF/ALA Rte: 80 PM: 13.2/13.9File #: 69.28**WELDING INSPECTION REPORT****Resident Engineer:** Pursell, Gary**Address:** 333 Burma Road**City:** Oakland, CA 94607**Report No:** WIR-001461**Date Inspected:** 20-Feb-2008**Project Name:** SAS Superstructure**OSM Arrival Time:** 1900**Prime Contractor:** American Bridge/Fluor Enterprises, a JV**OSM Departure Time:** 200**Contractor:** Zhenhua Port Machinery Company, Ltd (ZPMC), Changxing Island **Location:** Shanghai, China**CWI Name:** Wen Pang Huang**CWI Present:** Yes No**Inspected CWI report:** Yes No N/A**Rod Oven in Use:** Yes No N/A**Electrode to specification:** Yes No N/A**Weld Procedures Followed:** Yes No N/A**Qualified Welders:** Yes No N/A**Verified Joint Fit-up:** Yes No N/A**Approved Drawings:** Yes No N/A**Approved WPS:** Yes No N/A**Delayed / Cancelled:** Yes No N/A**Bridge No:** 34-0006**Component:** OBG**Summary of Items Observed:**

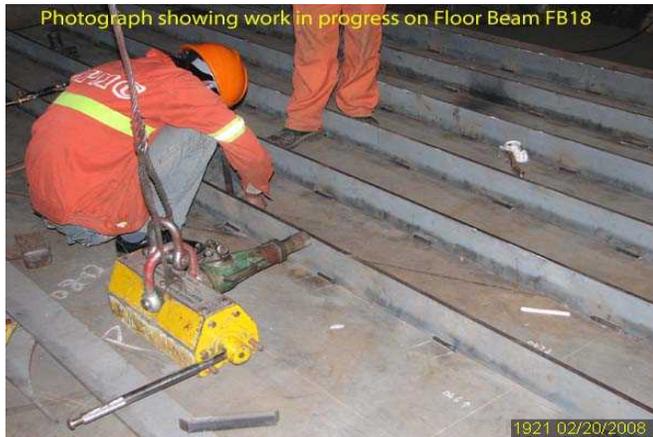
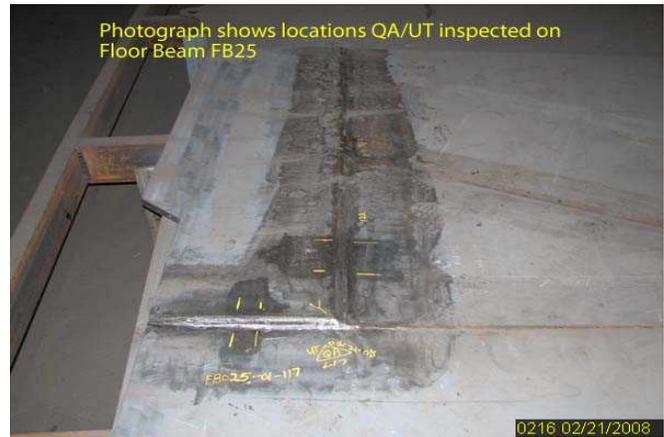
Bay 7- QA Inspector randomly observed ZPMC qualified welder Hong Shuili Identification (ID) #044815 utilizing the Flux Core Arc Welding (FCAW) process per the approved Weld Procedure Specification (WPS) WPS-B-T-2132-3 while performing tack welding on stiffeners on Floor Beam FB18 at weld joints FB018-001-030 and FB018-001-031. QA Inspector observed ZPMC QC Inspector Wen Pang Huang monitoring welding and preheating parameters. The QA Inspector also randomly monitored weld parameters used and recorded them as the following: 300 amps, 28 volts. The weld parameters appeared to comply with contract requirements and the approved WPS.

Bay 7- QA Inspector performed ultrasonic verification testing of Floor Beam Sub Assembly Complete Joint Penetration (CJP) welds on Floor Beams FB25-01, FB25-02, FB21-01 and FB22-02 at welds FB025-01-117, FB025-01-122, FB025-02-117, FB025-02-122, FB021-01-117, FB021-01-122, FB022-02-117 and FB022-02-122. The Ultrasonic Testing (UT) was performed to verify that 10% of the welds meet the requirements of the contract documents and AWS D1.5-2002. The weld and base metal were scanned utilizing a Krautkramer Branson USN 60. QA Inspector performed a base metal lamination check using a 25mm diameter 2.25 MHz transducer and a shear wave scan was using a 20mm x 15mm 2.25 MHz transducer on a 70 degree angle

wedge from face A. QA Inspector utilized Scanning patterns A, B, C, and E. For details please see the ultrasonic testing report TL-6027 dated February 20, 2008. QA Inspector found the welds inspected to be in compliance with AWS D1.5- 2002 Table 6.3 and the contract documents.
