Contract #: 04-0120F4Cty: SF/ALA Rte: 80 PM: 13.2/13.9File #: 69.28**WELDING INSPECTION REPORT****Resident Engineer:** Pursell, Gary**Address:** 333 Burma Road**City:** Oakland, CA 94607**Report No:** WIR-001518**Date Inspected:** 18-Feb-2008**Project Name:** SAS Superstructure**OSM Arrival Time:** 1830**Prime Contractor:** American Bridge/Fluor Enterprises, a JV**OSM Departure Time:** 900**Contractor:** Zhenhua Port Machinery Company, Ltd (ZPMC), Changxing Island **Location:** Shanghai, China**CWI Name:** Sha Zhi**CWI Present:** Yes No**Inspected CWI report:** Yes No N/A**Rod Oven in Use:** Yes No N/A**Electrode to specification:** Yes No N/A**Weld Procedures Followed:** Yes No N/A**Qualified Welders:** Yes No N/A**Verified Joint Fit-up:** Yes No N/A**Approved Drawings:** Yes No N/A**Approved WPS:** Yes No N/A**Delayed / Cancelled:** Yes No N/A**Bridge No:** 34-0006**Component:** 89M Mock-Up**Summary of Items Observed:**

Caltrans Quality Assurance (QA) Inspector, Mike Hasler was present to observe the fitup, welding and related activities associated with the fabricating of Caltrans Mock-up, 77M, 89M, 114M and U-Rib Trial Assembly, for the San Francisco Oakland Bay Self Anchored S

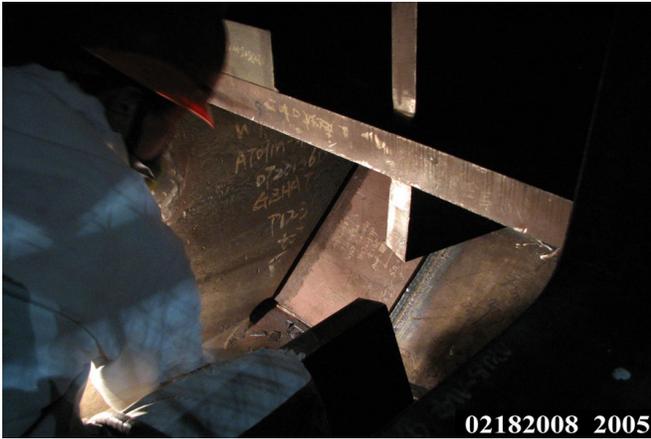
89M Mock-Up: Caltrans QA Inspector observed flux cored arc welding (FCAW) complete joint penetration (CJP) welding in progress in the New Tower Shop. The assembly is identified as SA184 – SA194 (MUB-MA21 J/J-20). The welder is identified as Mr. Pan Meng, welder #66673, welding in the 3G (vertical position). The welder is using welding procedure specification WPS-B-T2233-B-U2a-F, Revision 0. Caltrans QA Inspector measured current welding parameters at approximately 210 amps, 26.5 volts and 112 millimeters per minute (mm/min) travel speed. Preheat and interpass temperatures were verified during welding activities. The preheat temperature prior to the start of welding measures more than 110 Celsius (230 degree Fahrenheit) but less than 232 Celsius (450 degrees Fahrenheit) during maximum interpass temperature verification. FCAW welding consumable is verified and identified as Supercored 71H, classification E71T-1, diameter 1.4 mm (.055 inches). Caltrans QA observed ZPMC Quality Control (QC) Certified Welding Inspector (CWI) Mr. Sha Zhi monitoring welding activities at the workstation. The following digital pictures illustrate welding in progress.
