Contract #: 04-0120F4Cty: SF/ALA Rte: 80 PM: 13.2/13.9File #: 69.28**WELDING INSPECTION REPORT****Resident Engineer:** Pursell, Gary**Address:** 333 Burma Road**City:** Oakland, CA 94607**Report No:** WIR-001648**Date Inspected:** 25-Feb-2008**Project Name:** SAS Superstructure**OSM Arrival Time:** 630**Prime Contractor:** American Bridge/Fluor Enterprises, a JV**OSM Departure Time:** 1600**Contractor:** Zhenhua Port Machinery Company, Ltd (ZPMC), Changxing Island **Location:** Shanghai, China**CWI Name:** Chen Xi**CWI Present:** Yes No**Inspected CWI report:** Yes No N/A**Rod Oven in Use:** Yes No N/A**Electrode to specification:** Yes No N/A**Weld Procedures Followed:** Yes No N/A**Qualified Welders:** Yes No N/A**Verified Joint Fit-up:** Yes No N/A**Approved Drawings:** Yes No N/A**Approved WPS:** Yes No N/A**Delayed / Cancelled:** Yes No N/A**Bridge No:** 34-0006**Component:** Deck plate u-rib welding**Summary of Items Observed:**

Caltrans Quality Assurance (QA) Inspector, Mike Hasler was present to observe the fitup, welding and related activities associated with the fabricating of Caltrans Mock-up, 77M, 89M, 114M and the orthotropic box girders, for the San Francisco Oakland

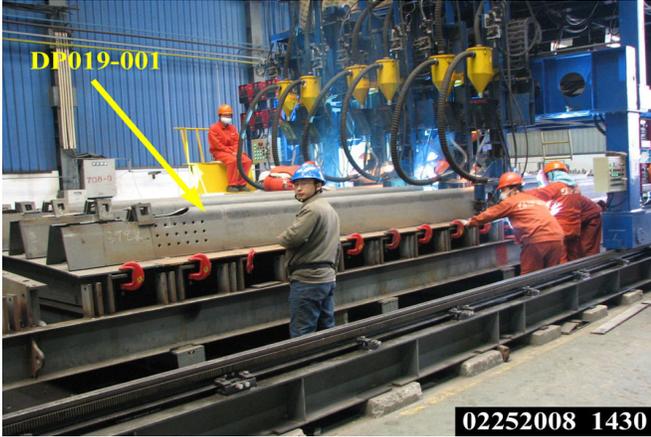
OBG Bay 1: OBG -Production Monitoring Test (PMT) #12 for closed rib welding on Deck Plates DP-019-001 and DP-017-001 gas metal arc welding (GMAW) and submerged arc welding (SAW) is being performed with gantry number 2. The GMAW of the production monitoring test is being performed in sequence with the welding of the deck plate DP-019-001. Prior to GMAW of the closed rib partial joint penetration (PJP) groove welds. Caltrans QA observed the surface condition of the surfaces where welding is to be applied. Caltrans QA identified cases of rust within the PJP groove that was brought to the attention of ZPMC and was removed by electrical powered wire wheel brushing. The Caltrans QA identified a GMAW tack weld that has a crack and also observed ZPMC in process of performing a repair of an additional GMAW tack weld. ZPMC removed these GMAW tack welds by grinding and then performed magnetic particle testing (MT) of the GMAW cracked tack weld area. ZPMC reported no discrepancies after MT and rewelded the GMAW tack weld. There was no SAW performed of the PMT or deck plate DP-019-001. There was also no GMAW applied to deck plate DP-017-001 during Caltrans QA Inspector's presence. Visual Test (VT) results of the PJP welds were not completed during Caltrans QA Inspector's presence. The following digital picture illustrates deck panel DP019-001 at gantry #2.
