DEPARTMENT OF TRANSPORTATION

Quality Assurance and Source Inspection

Contract #: 04-0120F4Cty: SF/ALA Rte: 80 PM: 13.2/13.9File #: 69.28**WELDING INSPECTION REPORT****Resident Engineer:** Pursell, Gary**Address:** 333 Burma Road**City:** Oakland, CA 94607**Report No:** WIR-001811**Date Inspected:** 20-Mar-2008**Project Name:** SAS Superstructure**OSM Arrival Time:** 1800**Prime Contractor:** American Bridge/Fluor Enterprises, a JV**OSM Departure Time:** 730**Contractor:** Zhenhua Port Machinery Company, Ltd (ZPMC), Changxing Island **Location:** Shanghai, China

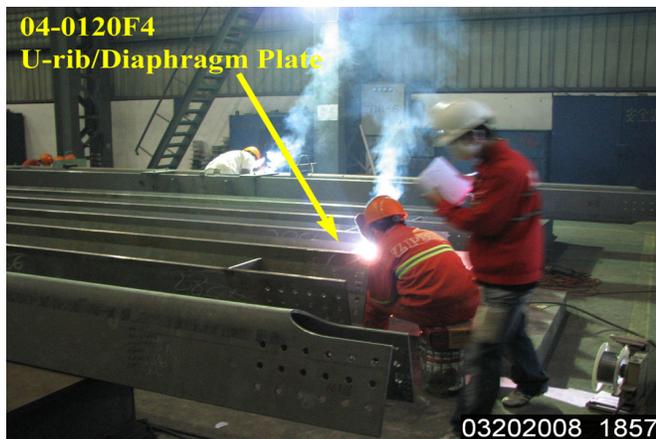
Item Description	WBS	Dwg No.	Status
1 U-rib Diaphragm Plate	NA	NA	Welding in progress.

OBG Bay 1: Caltrans QA Inspector observed flux cored arc welding (FCAW) interior diaphragm plate to u-rib. The welder is identified as Mr. Zhao Changshuang, welder identification number 059400, welding a fillet weld in the vertical position, using welding procedure specification WPS-B-T-2133, Revision 2. The weld is identified as DP297-001-088. Caltrans QA measured current welding parameters at approximately 205 amps, 25.5 volts and 105 millimeters per minute (mm/min) travel speed. The FCAW welding consumable is verified and identified as Supercored /71H, classification E71T-1, diameter 1.4 mm. Caltrans QA observed ZPMC Quality Control (QC), Mr. Chen Shiqang monitoring welding activities at the workstation. The following digital pictures illustrate welding in progress.

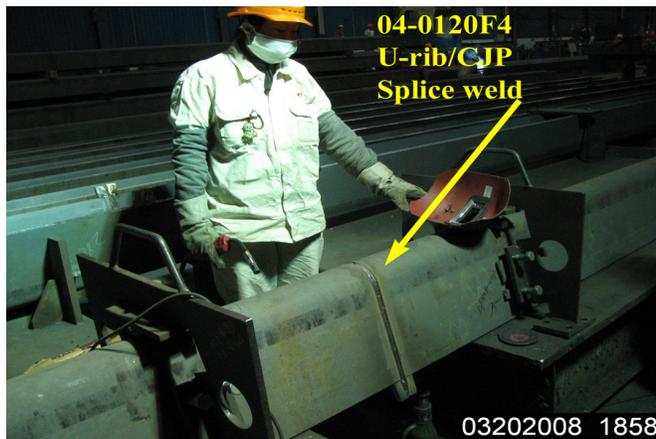
- 2 U-rib NA NA Welding in progress.

OBG Bay 1: Caltrans QA Inspector observed flux cored arc welding (FCAW) u-rib splice weld. The welder is identified as Mr. Dong Yi Qun, welder identification number 059450, welding a complete joint penetration (CJP) weld in the vertical position, using welding procedure specification WPS-B-T-2133-B-U2-F. The weld is identified as DP004-001-010. Caltrans QA measured current welding parameters at approximately 205 amps, 25.0 volts and 105 millimeters per minute (mm/min) travel speed. The FCAW welding consumable is verified and identified as Supercored /71H, classification E71T-1, diameter 1.4 mm. Caltrans QA observed ZPMC Quality Control (QC), Mr. Chen Shiqang monitoring welding activities at the workstation. The following digital pictures illustrate welding in progress.
