DEPARTMENT OF TRANSPORTATION

Contract #: 04-0120F4Cty: SF/ALA Rte: 80 PM: 13.2/13.9File #: 69.28**WELDING INSPECTION REPORT****Resident Engineer:** Pursell, Gary**Address:** 333 Burma Road**City:** Oakland, CA 94607**Report No:** WIR-001893**Date Inspected:** 23-Mar-2008**Project Name:** SAS Superstructure**OSM Arrival Time:** 630**Prime Contractor:** American Bridge/Fluor Enterprises, a JV**OSM Departure Time:** 1730**Contractor:** Zhenhua Port Machinery Company, Ltd (ZPMC), Changxing Island **Location:** Shanghai, China**CWI Name:** Huang Wei Qing, Sha Zhi**CWI Present:** Yes No**Inspected CWI report:** Yes No N/A**Rod Oven in Use:** Yes No N/A**Electrode to specification:** Yes No N/A**Weld Procedures Followed:** Yes No N/A**Qualified Welders:** Yes No N/A**Verified Joint Fit-up:** Yes No N/A**Approved Drawings:** Yes No N/A**Approved WPS:** Yes No N/A**Delayed / Cancelled:** Yes No N/A**Bridge No:** 34-0006**Component:** OBG/Tower**Summary of Items Observed:**

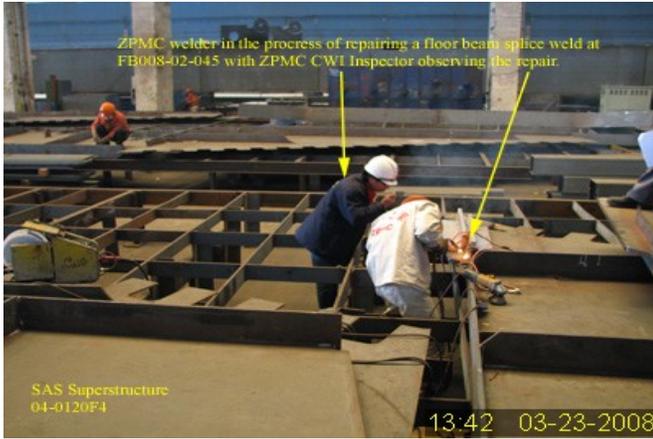
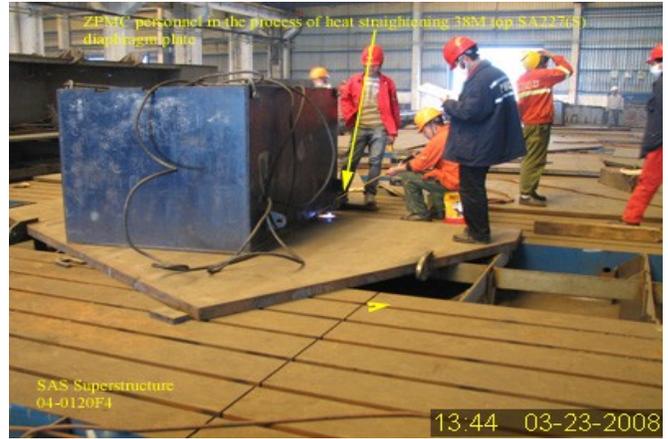
QA Inspector Brannon randomly observed ZPMC personnel performing heat straightening diaphragm plate SA227 (S). ZPMC report #HSR1 (T)-188-1st lift, 38M top SA227 (S). Cause for heat straightening mill induced distortion. Heat Straightening is performed by flame straightening by natural gas using a hand torch.

The following digital photograph below illustrates observation of the activities being performed.
