Contract #: 04-0120F4Cty: SF/ALA Rte: 80 PM: 13.2/13.9File #: 69.28**WELDING INSPECTION REPORT****Resident Engineer:** Pursell, Gary**Address:** 333 Burma Road**City:** Oakland, CA 94607**Report No:** WIR-001972**Date Inspected:** 15-Apr-2008**Project Name:** SAS Superstructure**OSM Arrival Time:** 2300**Prime Contractor:** American Bridge/Fluor Enterprises, a JV**OSM Departure Time:** 730**Contractor:** Zhenhua Port Machinery Company, Ltd (ZPMC), Changxing Island **Location:** Shanghai, China**CWI Name:** See below**CWI Present:** Yes No**Inspected CWI report:** Yes No N/A**Rod Oven in Use:** Yes No N/A**Electrode to specification:** Yes No N/A**Weld Procedures Followed:** Yes No N/A**Qualified Welders:** Yes No N/A**Verified Joint Fit-up:** Yes No N/A**Approved Drawings:** Yes No N/A**Approved WPS:** Yes No N/A**Delayed / Cancelled:** Yes No N/A**Bridge No:** 34-0006**Component:** Tower and OBG Fabrication**Summary of Items Observed:**

Caltrans Quality Assurance (QA) Inspector, Mr. Paul Dawson, arrived on site at the Zhenhua Port Machinery Company (ZPMC) facility at Changxing Island, in Shanghai, China, for the purpose of monitoring welding and fabrication of the San Francisco /

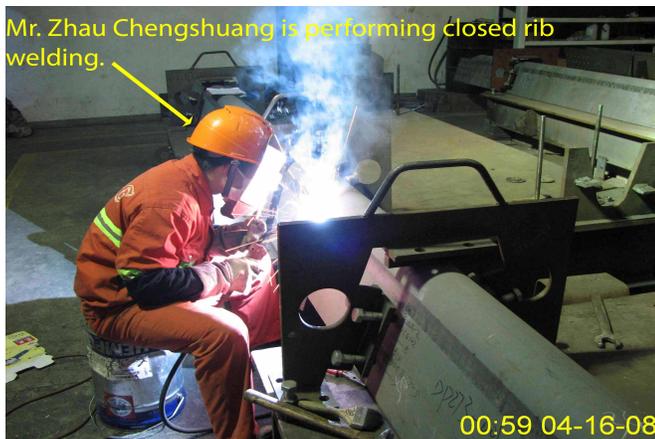
The QA Inspector observed ZPMC welder Mr. Zhao Chengshuang, stencil 59400 is using welding procedure specification WPS-B-T-2233-B-U2-F to make flux cored closed rib splice weld DP111-001-155. Prior to welding the QA Inspector observed the groove area where Mr. Zhiwu was preparing to weld had been backgouged and ground to a bright metal surface. The QA Inspector observed a welding current of approximately 210 amps and 23.9 volts. Items observed by the QA Inspector appear to comply with project specifications. See the photograph below for additional information.
