DEPARTMENT OF TRANSPORTATION

Quality Assurance and Source Inspection

Contract #: 04-0120F4Cty: SF/ALA Rte: 80 PM: 13.2/13.9File #: 69.28**WELDING INSPECTION REPORT****Resident Engineer:** Pursell, Gary**Address:** 333 Burma Road**City:** Oakland, CA 94607**Report No:** WIR-001993**Date Inspected:** 22-Apr-2008**Project Name:** SAS Superstructure**OSM Arrival Time:** 1500**Prime Contractor:** American Bridge/Fluor Enterprises, a JV**OSM Departure Time:** 2200**Contractor:** Zhenhua Port Machinery Company, Ltd (ZPMC), Changxing Island **Location:** Shanghai, China**CWI Name:** Zhao Gang Luan**CWI Present:** Yes No**Inspected CWI report:** Yes No N/A**Rod Oven in Use:** Yes No N/A**Electrode to specification:** Yes No N/A**Weld Procedures Followed:** Yes No N/A**Qualified Welders:** Yes No N/A**Verified Joint Fit-up:** Yes No N/A**Approved Drawings:** Yes No N/A**Approved WPS:** Yes No N/A**Delayed / Cancelled:** Yes No N/A**Bridge No:** 34-0006**Component:** OBG**Summary of Items Observed:**

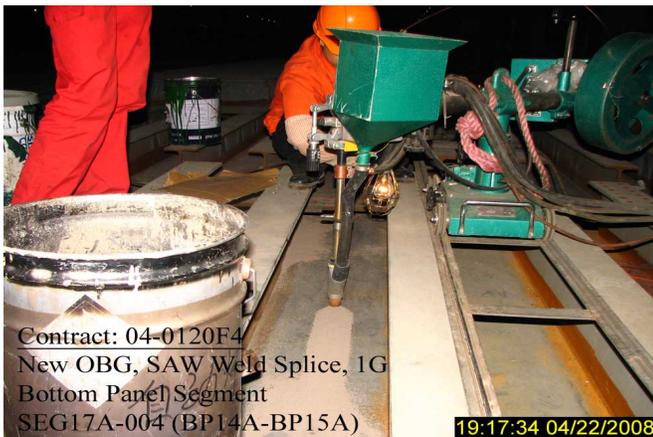
The QA Inspector made a random observation to this shop and observed that ZPMC personnel were in the process of performing submerged arc welding (SAW) for a splice weld on bottom panel segment designation SEG17A-004 (BP14A-BP15A) 4A-D6W (see digital picture below). The QA Inspector reviewed the CWI welding inspection report provided by ZPMC CWI Zhao Gang Luan and noted 627 amperes for the welding current, 31.6 volts and 485 mm for the recorded travel speed. The QA Inspector performed a random measurement of the welding parameters observing little variation from the information mentioned above. The QA Inspector observed Mr. Zhao Gang Luan perform a measurement of the interpass temperature with a hand held thermal heat gun and record approximately 162 degrees Celsius. The interpass temperature was verified in several locations along the weld length with little variation from the recorded measurement mentioned above. The QA Inspector was informed by ABF QC Inspection personnel Wang Cheng that the welding is being performed to the requirements of welding procedure specification (WPS)-B-T-223(2) 1T. The welder at this location was identified as Wang Lan Ying, identification 045265 and was welding two cover passes at the time of this observation. The welding and workmanship randomly observed at this location appeared to comply with the noted WPS and the contract specifications.
