Contract #: 04-0120F4Cty: SF/ALA Rte: 80 PM: 13.2/13.9File #: 69.28**WELDING INSPECTION REPORT****Resident Engineer:** Pursell, Gary**Address:** 333 Burma Road**City:** Oakland, CA 94607**Report No:** WIR-002070**Date Inspected:** 05-Apr-2008**Project Name:** SAS Superstructure**OSM Arrival Time:** 2300**Prime Contractor:** American Bridge/Fluor Enterprises, a JV**OSM Departure Time:** 730**Contractor:** Zhenhua Port Machinery Company, Ltd (ZPMC), Changxing Island **Location:** Shanghai, China**CWI Name:** See below**CWI Present:** Yes No**Inspected CWI report:** Yes No N/A**Rod Oven in Use:** Yes No N/A**Electrode to specification:** Yes No N/A**Weld Procedures Followed:** Yes No N/A**Qualified Welders:** Yes No N/A**Verified Joint Fit-up:** Yes No N/A**Approved Drawings:** Yes No N/A**Approved WPS:** Yes No N/A**Delayed / Cancelled:** Yes No N/A**Bridge No:** 34-0006**Component:** Tower and OBG Fabrication**Summary of Items Observed:**

Caltrans Quality Assurance (QA) Inspector, Mr. Paul Dawson, arrived on site at the Zhenhua Port Machinery Company (ZPMC) facility at Changxing Island, in Shanghai, China, for the purpose of monitoring welding and fabrication of the San Francisco /

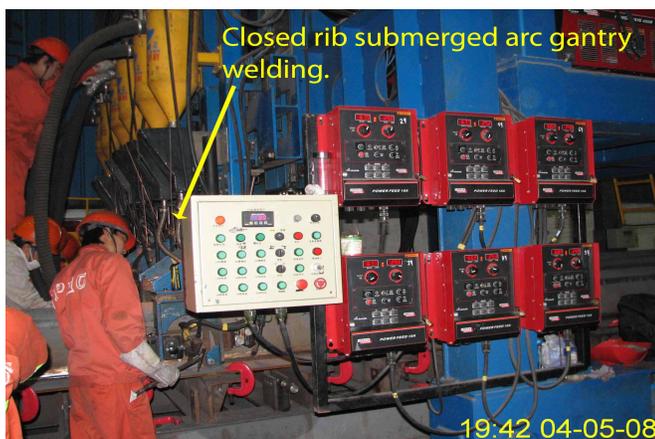
Closed rib U163 weld #1 welder Mr. Xu Guo Yin, stencil 59443 has a welding current of 680 amps and 25.0 volts; closed rib U163 weld #2 welder Mr. Xiang Jie, stencil 59378 has a welding current of 680 amps and 25.0 volts; closed rib U166 weld #5 welder Mr. Guo Xin Dong, stencil 59361 has a welding current of 680 amps and 25.0 volts; closed rib U166 weld #6 welder Mr. Jiang Ting Guang, stencil 62265, has a welding current of 680 amps and 25.0 volts; closed rib U162 weld #9 welder Mr. Chen Jie, stencil 59468 has a welding current of 680 amps and 25.0 volts; closed rib U162 weld #10 welder Mr. Xiang Huan Feng, stencil 59416 has a welding current of 680 amps and 25.0 volts. The welding travel speed is approximately 510 mm per minute. Items observed by the QA Inspector appear to comply with project specifications. See the photograph below for additional information.
