Contract #: 04-0120F4Cty: SF/ALA Rte: 80 PM: 13.2/13.9File #: 69.28**WELDING INSPECTION REPORT****Resident Engineer:** Pursell, Gary**Address:** 333 Burma Road**City:** Oakland, CA 94607**Report No:** WIR-002312**Date Inspected:** 10-May-2008**Project Name:** SAS Superstructure**OSM Arrival Time:** 1400**Prime Contractor:** American Bridge/Fluor Enterprises, a JV**OSM Departure Time:** 2300**Contractor:** Zhenhua Port Machinery Company, Ltd (ZPMC), Changxing Island **Location:** Shanghai, China

New Tower Bay 1

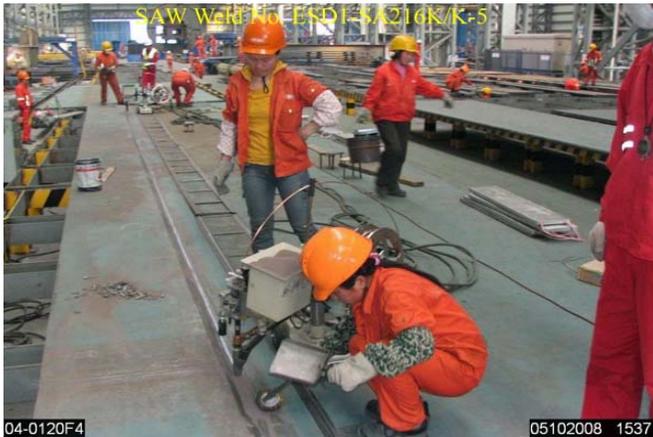
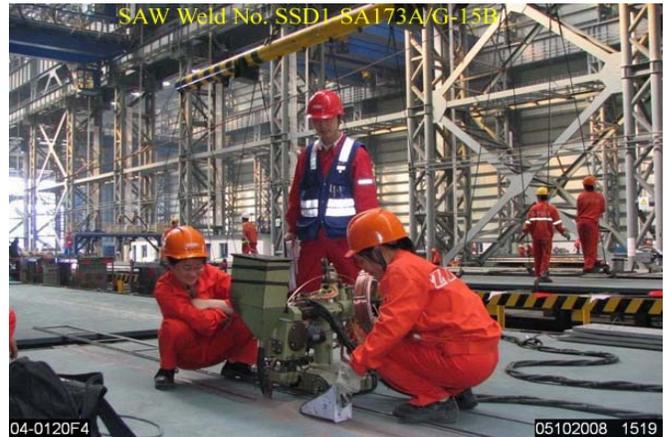
The Caltrans QA Inspector randomly observed the Submerged Arc Welding (SAW) of fill passes on Weld No. ESD1-SA210 J/K-9A by welding operator Xu Yian (I. D. No. 040634); and Weld No. ESD1-SA216J/K-7A by welding operator Shen Mei (I. D. No. 041716). Both welds were made in the flat groove (1G) welding position using Welding Procedure Specification (WPS) No. was WPS-B-T-2221-B-U3c-S. Certified Welding Inspector (CWI), Jiang Jian Fei (CWI No. 07120691) was present during this welding. The QA Inspector verified the qualifications of the welding operator, and that the electrode/flux classification, diameter of electrode, amperage, voltage, travel speed, and preheat/interpass temperatures were as specified on the WPS.

The Caltrans QA Inspector also randomly observed the Submerged Arc Welding (SAW) of fill passes on Weld No. SSD1-SA173 A/G-15B in the flat groove (1G) welding position. The welding operator was Xu Yen (I. D. No. 052917) and the Welding Procedure Specification (WPS) No. was WPS-B-T-2221-B-U3c-S. Certified Welding Inspector (CWI), An Qing Xiang (CWI No. 07120651) was present during this welding. The QA Inspector verified the qualifications of the welding operator, and that the electrode/flux classification, diameter of electrode, amperage, voltage, and preheat/interpass temperatures were as specified on the WPS. The QA Inspector later observed the SAW of the opposite side of this joint, Weld No. SSD1-SA173 A/G-15A by the same welding

The Caltrans QA Inspector also randomly observed the Submerged Arc Welding (SAW) of fill passes on Weld No. SSD1-SA173 B/K-7A in the flat groove (1G) welding position. The welding operator was Yun Chuan Jin (I. D. No. 0503060) and the Welding Procedure Specification (WPS) No. was WPS-B-T-2221-B-U3c-S. Certified Welding Inspector (CWI), Xu Le Feng was present during this welding. The QA Inspector verified the qualifications of the welding operator, and that the electrode/flux classification, diameter of electrode, amperage, voltage, and preheat/interpass temperatures were as specified on the WPS.

The QA Inspector also randomly observed the Flux Cored Arc Welding (FCAW) of Weld No. SSP1-SA159G/H-13A. The welder was Tao Qian (I. D. No. 040457) and the WPS No. was WPS-B-T-2231-B-U3-F. Certified Welding Inspector (CWI), An Qing Xiang (CWI No. 07120651) was present during this welding.

The Caltrans QA Inspector also randomly observed the Submerged Arc Welding (SAW) of fill passes on Weld No. ESD1-SA216 K/K-5 in the flat groove (1G) welding position. The welding operator was Cao Xiao Hua (I. D. No. 056975) and the Welding Procedure Specification (WPS) No. was WPS-B-T-2312-B-P3-S. Certified Welding Inspector (CWI), Zhu Zhong Hai was present during this welding. The QA Inspector verified the qualifications of the welding operator, and that the electrode/flux classification, diameter of electrode, amperage, voltage, travel speed, and preheat/interpass temperatures were as specified on the WPS.

All above observations appeared to meet the requirements of the job specifications.
