DEPARTMENT OF TRANSPORTATION

Contract #: 04-0120F4Cty: SF/ALA Rte: 80 PM: 13.2/13.9File #: 69.28**WELDING INSPECTION REPORT****Resident Engineer:** Pursell, Gary**Address:** 333 Burma Road**City:** Oakland, CA 94607**Report No:** WIR-002891**Date Inspected:** 24-May-2008**Project Name:** SAS Superstructure**OSM Arrival Time:** 1400**Prime Contractor:** American Bridge/Fluor Enterprises, a JV**OSM Departure Time:** 2300**Contractor:** Zhenhua Port Machinery Company, Ltd (ZPMC), Changxing Island **Location:** Shanghai, China**CWI Name:** Chen Xi**CWI Present:** Yes No**Inspected CWI report:** Yes No N/A**Rod Oven in Use:** Yes No N/A**Electrode to specification:** Yes No N/A**Weld Procedures Followed:** Yes No N/A**Qualified Welders:** Yes No N/A**Verified Joint Fit-up:** Yes No N/A**Approved Drawings:** Yes No N/A**Approved WPS:** Yes No N/A**Delayed / Cancelled:** Yes No N/A**Bridge No:** 34-0006**Component:** OBG**Summary of Items Observed:**

WELDING INSPECTION REPORT

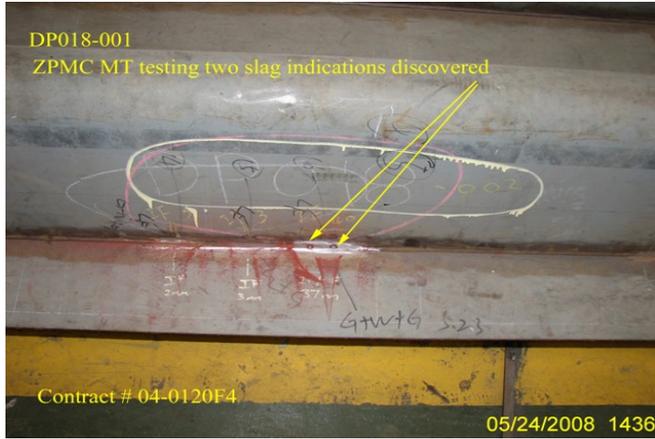
The QA Inspector observed as MT Technician Bo Tin Rin discovered two slag indications in a repaired weld on deck panel DP018-002. The QA Inspector informed ZPMC QC Inspector Li Xiuyang about the slag indications, and Mr. Li Xiuyang decided to delay the rest of the MT inspections until the slag indications could be repaired. No further MT on deck panel repair was observed on this date.
