DEPARTMENT OF TRANSPORTATION

Contract #: 04-0120F4Cty: SF/ALA Rte: 80 PM: 13.2/13.9File #: 69.28**WELDING INSPECTION REPORT****Resident Engineer:** Pursell, Gary**Address:** 333 Burma Road**City:** Oakland, CA 94607**Report No:** WIR-002768**Date Inspected:** 30-Jun-2008**Project Name:** SAS Superstructure**OSM Arrival Time:** 2300**Prime Contractor:** American Bridge/Fluor Enterprises, a JV**OSM Departure Time:** 730**Contractor:** Zhenhua Port Machinery Company, Ltd (ZPMC), Changxing Island **Location:** Shanghai, China

New Tower Bay 2

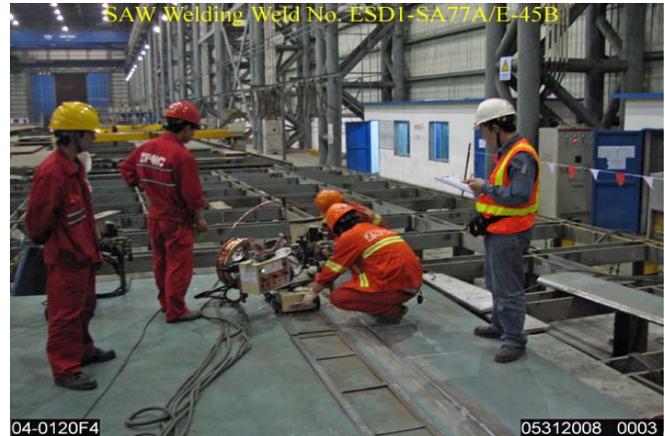
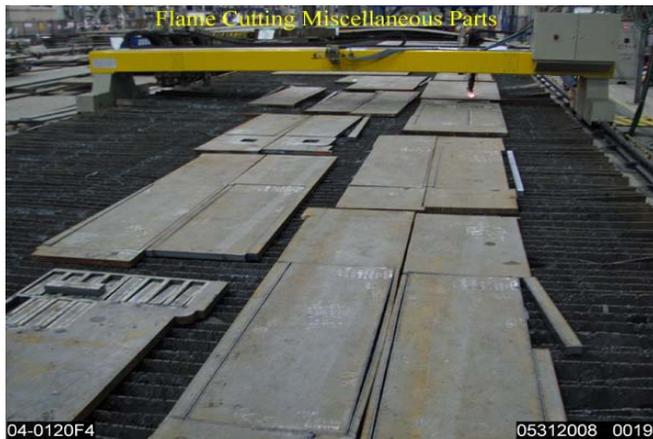
The Caltrans QA Inspector randomly observed the machine Submerged Arc Welding (SAW) of fill passes on Weld No. ESD1-SA77 A/E-45B, Skin Plate Face C. The welding operator was Wu Zhi Jun (I. D. No. 062611). The welding was in the flat groove (1G) position using Welding Procedure Specification (WPS) No. WPS-B-T-2221-B-U3c-S. Certified Welding Inspector (CWI), Jiang Jian Fei (CWI No. 07120691) was present during this welding as was ABF QA Inspector, Yang Yi heng. The QA Inspector verified the electrode as JW-3 (EM12K) and the diameter of the electrode as 4.0 mm. The minimum preheat and maximum interpass temperatures, voltage, amperage and travel speed were all verified as being within the parameters of the WPS.

The Caltrans QA Inspector also randomly observed the machine Submerged Arc Welding (SAW) of fill passes on Weld No. ESD1-SA294 A/G-12B, Skin Plate Face C. The welding operator was Cao Gui mei (I. D. No. 047304). The welding was in the flat groove (1G) position using Welding Procedure Specification (WPS) No. WPS-B-T-2221-B-U3c-S. Certified Welding Inspector (CWI), Jiang Jian Fei (CWI No. 07120691) was present during this welding as was ABF QA Inspector, Yang Yi heng. The QA Inspector verified the qualifications of the welding operator, the electrode as JW-3 (EM12K) and the diameter of the electrode as 4.0 mm. The minimum preheat and maximum interpass temperatures, voltage, amperage and travel speed were all verified as being within

The Caltrans QA Inspector also observed the machining of the weld bevel on stiffeners (Member I. D's. p326 and p503B) for Tower deck plate.

The Caltrans QA Inspector also observed flame cutting at two work stations of miscellaneous for the tower.

All above observations appeared to meet the requirements of the job specifications.
