Contract #: 04-0120F4Cty: SF/ALA Rte: 80 PM: 13.2/13.9File #: 69.28**WELDING INSPECTION REPORT****Resident Engineer:** Pursell, Gary**Address:** 333 Burma Road**City:** Oakland, CA 94607**Report No:** WIR-002822**Date Inspected:** 04-Jun-2008**Project Name:** SAS Superstructure**OSM Arrival Time:** 1700**Prime Contractor:** American Bridge/Fluor Enterprises, a JV**OSM Departure Time:** 730**Contractor:** Zhenhua Port Machinery Company, Ltd (ZPMC), Changxing Island **Location:** Shanghai, China**CWI Name:** Jiang Jian Fei, Xu Le feng**CWI Present:** Yes No**Inspected CWI report:** Yes No N/A**Rod Oven in Use:** Yes No N/A**Electrode to specification:** Yes No N/A**Weld Procedures Followed:** Yes No N/A**Qualified Welders:** Yes No N/A**Verified Joint Fit-up:** Yes No N/A**Approved Drawings:** Yes No N/A**Approved WPS:** Yes No N/A**Delayed / Cancelled:** Yes No N/A**Bridge No:** 34-0006**Component:** Tower**Summary of Items Observed:**

WELDING INSPECTION REPORT

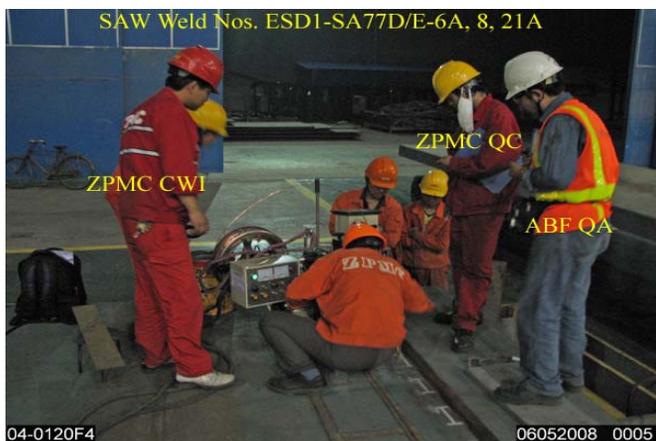
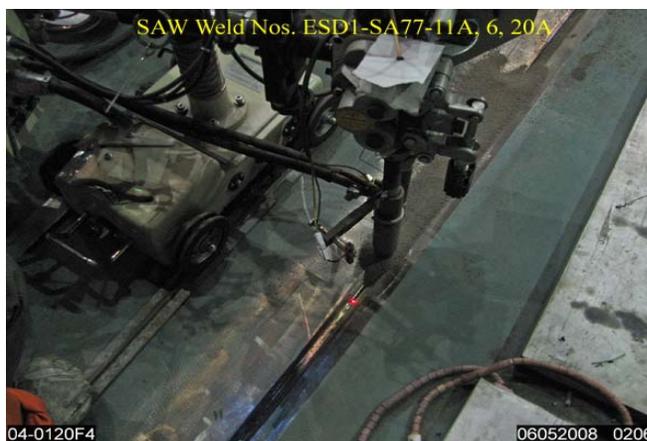
The Caltrans QA Inspector randomly observed the Shielded Metal Arc Welding (SMAW) of run-off tabs in the flat groove (1G) welding position on Weld Nos. ESD1-SA80-42A and ESD1-SA80-45A. The welder was Liu Wei (I. D. 048532). The QA Inspector verified the qualifications of the welder by looking at his qualification card.

The type electrode, E7018 (TL 508), was also verified and a portable electrode oven was in use. A ZPMC Quality Control Inspector was monitoring this work during the time of observation.

The Caltrans QA Inspector also randomly observed the Submerged Arc Welding (SAW) of the root pass on Weld Nos. ESD1-SA77 D/E-6A, 8, 21A and Weld Nos. ESD1-SA77 D/E-11A, 6, 20A in the flat groove (1G) welding position. Each of the three welds above are actually on one weld joint. The “A” welds are CJP and are at each end of the applicable joint and the remaining welds are PJP and are between the applicable CJP welds. The welding operator was Shen Mei (I. D. No. 041716) and the Welding Procedure Specification (WPS) No. was WPS-B-T-2221-B-U3c-S-1. Certified Welding Inspector (CWI), Jiang Jian Fei (CWI No. 07120691) was present during the welding of both welds, as was ABF QA Inspector, Yang Yi heng. The QA Inspector verified the qualifications of the welding operator, and that the electrode/flux classification, diameter of electrode, amperage, voltage, travel speed, and preheat/interpass temperatures were within the specified ranges on the WPS.

All above observations appeared to meet the requirements of the job specifications.
