DEPARTMENT OF TRANSPORTATION

Quality Assurance and Source Inspection

Contract #: 04-0120F4Cty: SF/ALA Rte: 80 PM: 13.2/13.9File #: 69.28**WELDING INSPECTION REPORT****Resident Engineer:** Pursell, Gary**Address:** 333 Burma Road**City:** Oakland, CA 94607**Report No:** WIR-003323**Date Inspected:** 18-Jul-2008**Project Name:** SAS Superstructure**OSM Arrival Time:** 700**Prime Contractor:** American Bridge/Fluor Enterprises, a JV**OSM Departure Time:** 1730**Contractor:** Zhenhua Port Machinery Company, Ltd (ZPMC), Changxing Island **Location:** Shanghai, China**CWI Name:** Keng Chan**CWI Present:** Yes No**Inspected CWI report:** Yes No N/A**Rod Oven in Use:** Yes No N/A**Electrode to specification:** Yes No N/A**Weld Procedures Followed:** Yes No N/A**Qualified Welders:** Yes No N/A**Verified Joint Fit-up:** Yes No N/A**Approved Drawings:** Yes No N/A**Approved WPS:** Yes No N/A**Delayed / Cancelled:** Yes No N/A**Bridge No:** 34-0006**Component:** Tower**Summary of Items Observed:**

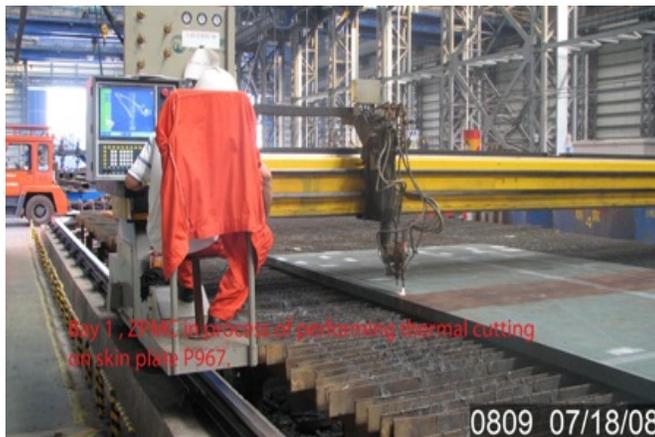
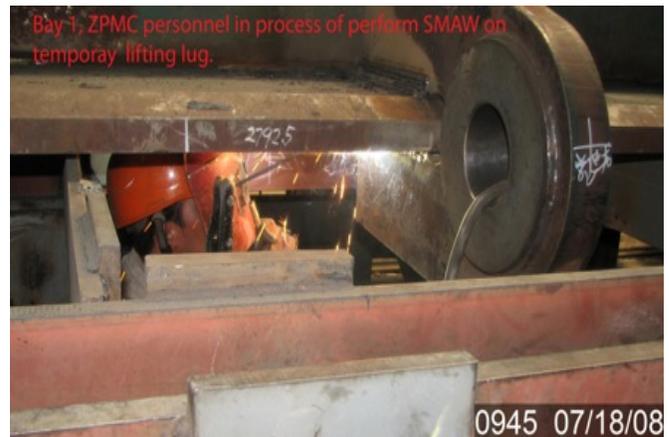
The Quality Assurance Inspector observed ZPMC Caltrans approved welders 067756 and 040500, utilizing shielded metal arc welding process on temporary lifting lugs to skin plate A South Tower Assembly. The Quality Assurance Inspector observed ZPMC Quality Control Personnel record parameters and verify preheat temperatures. The welding parameters observed by the Quality Assurance Inspector appeared to be within welding procedure specification WPS-B-P-2312-TC-PS. See digital photograph below.
