DEPARTMENT OF TRANSPORTATION

Contract #: 04-0120F4Cty: SF/ALA Rte: 80 PM: 13.2/13.9File #: 69.28**WELDING INSPECTION REPORT****Resident Engineer:** Pursell, Gary**Address:** 333 Burma Road**City:** Oakland, CA 94607**Report No:** WIR-003505**Date Inspected:** 14-Jul-2008**Project Name:** SAS Superstructure**OSM Arrival Time:** 2130**Prime Contractor:** American Bridge/Fluor Enterprises, a JV**OSM Departure Time:** 700**Contractor:** Zhenhua Port Machinery Company, Ltd (ZPMC), Changxing Island **Location:** Shanghai, China

Orthotropic Box Girder (OBG) Fabrication:

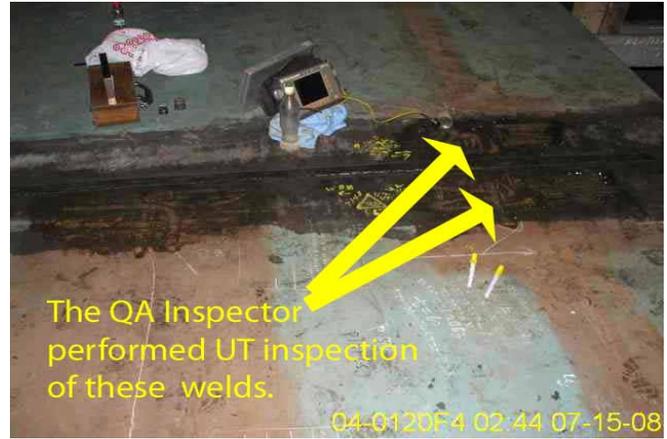
ZPMC "Notification of witness inspection document # 00661 dated 7-14-2008 states the above listed welds along with weld SSDI-SA173A/K-20A/B are to have been ultrasonically inspected today. The QA Inspector observed weld SSDI-SA173A/K-20A/B has been marked as "UT REJECT" by ZPMC ultrasonic inspection personnel. See the photograph below for additional information.
