DEPARTMENT OF TRANSPORTATION

Contract #: 04-0120F4Cty: SF/ALA Rte: 80 PM: 13.2/13.9File #: 69.28**WELDING INSPECTION REPORT****Resident Engineer:** Pursell, Gary**Address:** 333 Burma Road**City:** Oakland, CA 94607**Report No:** WIR-003534**Date Inspected:** 29-Jul-2008**Project Name:** SAS Superstructure**OSM Arrival Time:** 1400**Prime Contractor:** American Bridge/Fluor Enterprises, a JV**OSM Departure Time:** 2330**Contractor:** Zhenhua Port Machinery Company, Ltd (ZPMC), Changxing Island **Location:** Shanghai, China**CWI Name:** Sun Wei**CWI Present:** Yes No**Inspected CWI report:** Yes No N/A**Rod Oven in Use:** Yes No N/A**Electrode to specification:** Yes No N/A**Weld Procedures Followed:** Yes No N/A**Qualified Welders:** Yes No N/A**Verified Joint Fit-up:** Yes No N/A**Approved Drawings:** Yes No N/A**Approved WPS:** Yes No N/A**Delayed / Cancelled:** Yes No N/A**Bridge No:** 34-0006**Component:** OBG/T0wer**Summary of Items Observed:**

WELDING INSPECTION REPORT

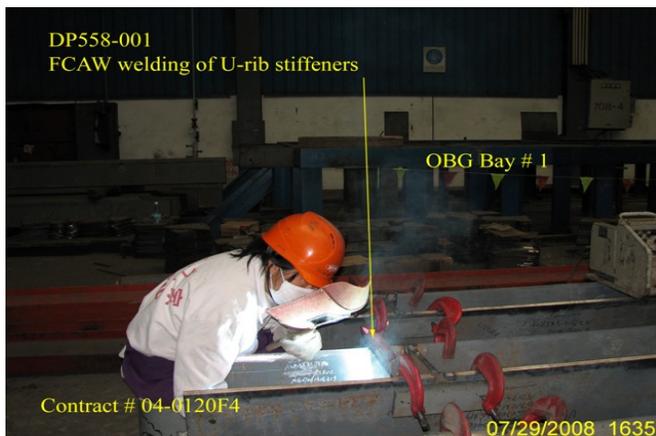
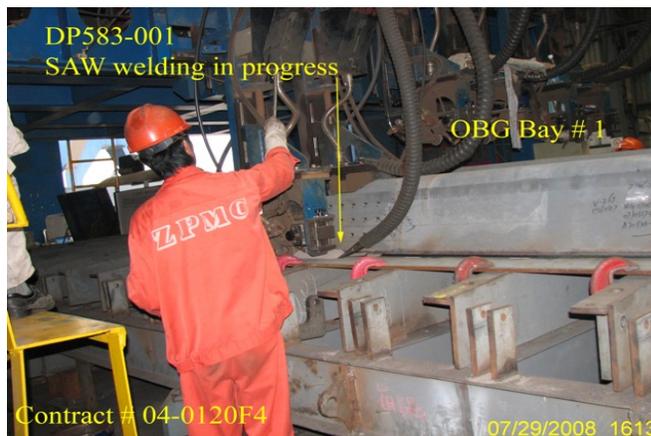
The QA Inspector observed the Flux Cored Arc welding in progress of U-rib stiffeners by ZPMC qualified and approved welder Dong Yi Qun ID 059450 to be used on DP558-001.

The welding in progress appeared to comply with the WPS-B-T-2133 and the contract requirements.

For more detail see photographs shown below:
