DEPARTMENT OF TRANSPORTATION

Contract #: 04-0120F4Cty: SF/ALA Rte: 80 PM: 13.2/13.9File #: 69.28**WELDING INSPECTION REPORT****Resident Engineer:** Pursell, Gary**Address:** 333 Burma Road**City:** Oakland, CA 94607**Report No:** WIR-003579**Date Inspected:** 06-Aug-2008**Project Name:** SAS Superstructure**OSM Arrival Time:** 1400**Prime Contractor:** American Bridge/Fluor Enterprises, a JV**OSM Departure Time:** 2330**Contractor:** Zhenhua Port Machinery Company, Ltd (ZPMC), Changxing Island **Location:** Shanghai, China

WELDING INSPECTION REPORT

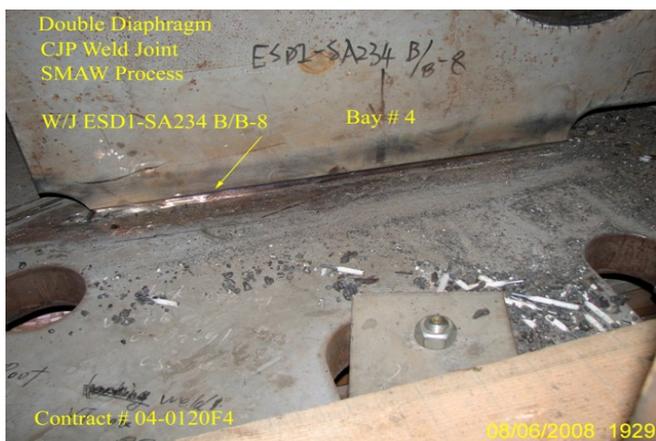
ESD1-SA234 B/B weld joint # 8. Qualified welder was observed welding in the 2G (horizontal) position utilizing shielded metal arc welding (SMAW) process with a 4.8mm diameter electrode, filler metal brand Excalibur 9018M MR, class E9018M manual. QA Inspector Dixon observed the ZPMC QC CWI Inspector Mr. Yu Dong Ping verifying that the welding parameters and pre-heat were in accordance with the Welding Procedure Specification (WPS). Welding parameters observed by QA Inspector Dixon appear to be in general compliance with the approved WPS-B-T-3312-Tc-P5.

The welding in progress generally appeared to conform to contract specifications.
